2023 Bensenville Park District Facilities Assessment

Bensenville
Park District

Executive Summary

The JSD Professional Services Team, which includes TRIA Architecture, was commissioned by the Bensenville Park District to conduct an assessment of their parks and buildings. The report includes the assessments of each of the 17 park sites, and the buildings associated with the Deer Grove Leisure Center, White Pines Golf Club, Water Park & Splash Pad Bathhouse, and the Buildings & Grounds Maintenance Facility.

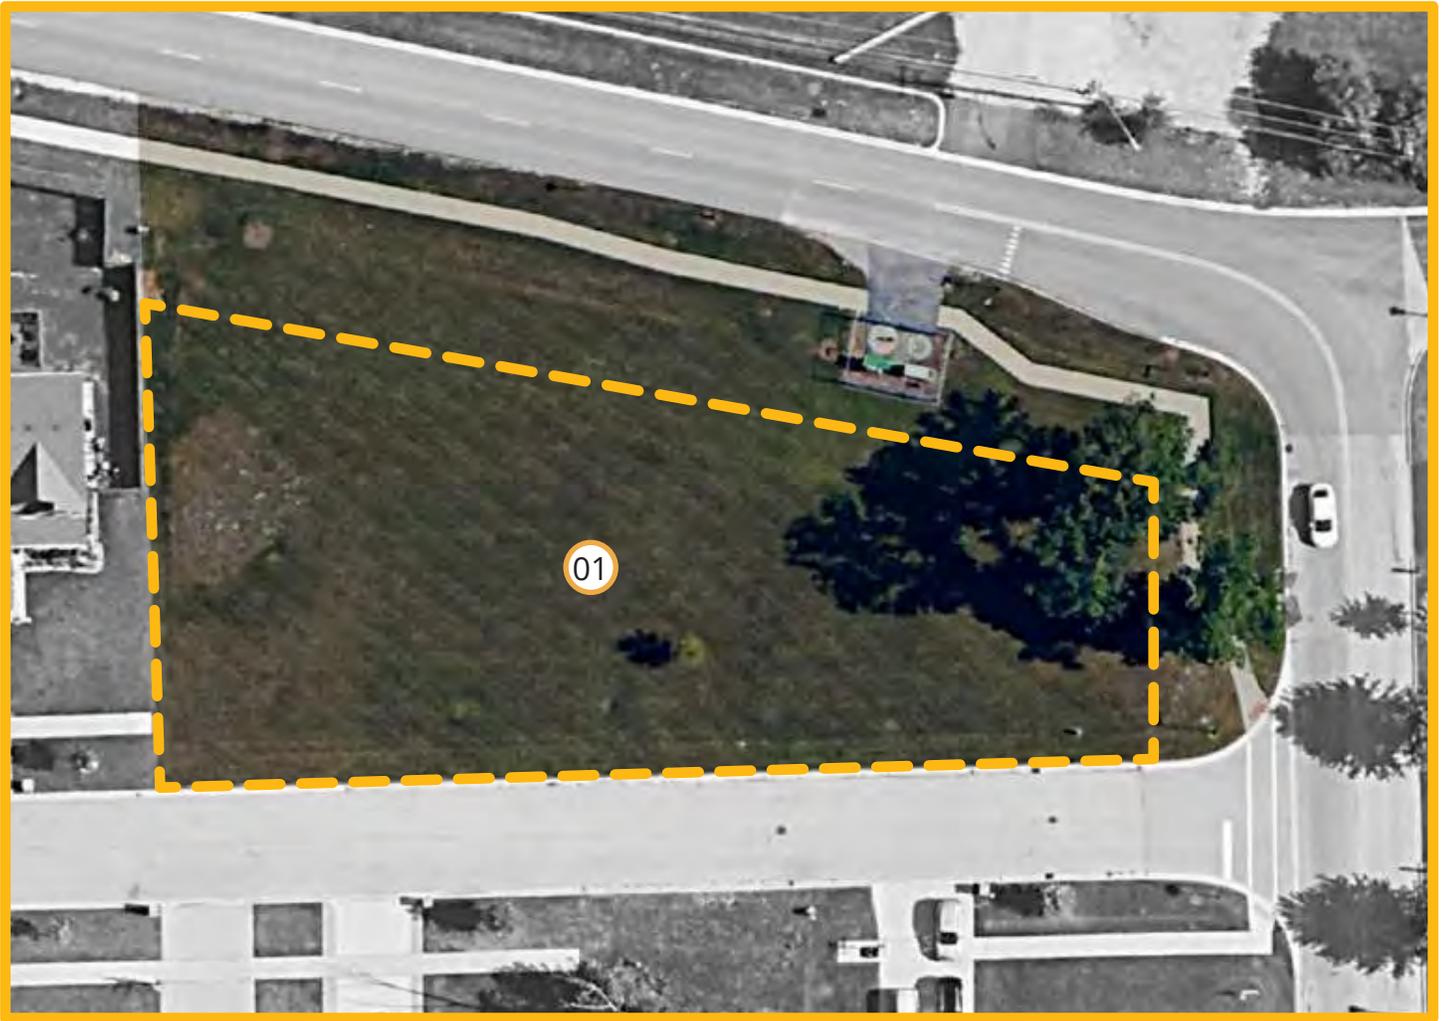
ARBOR WOODS PARK

01 Open Lawn

The trees and existing lawn are in good condition.

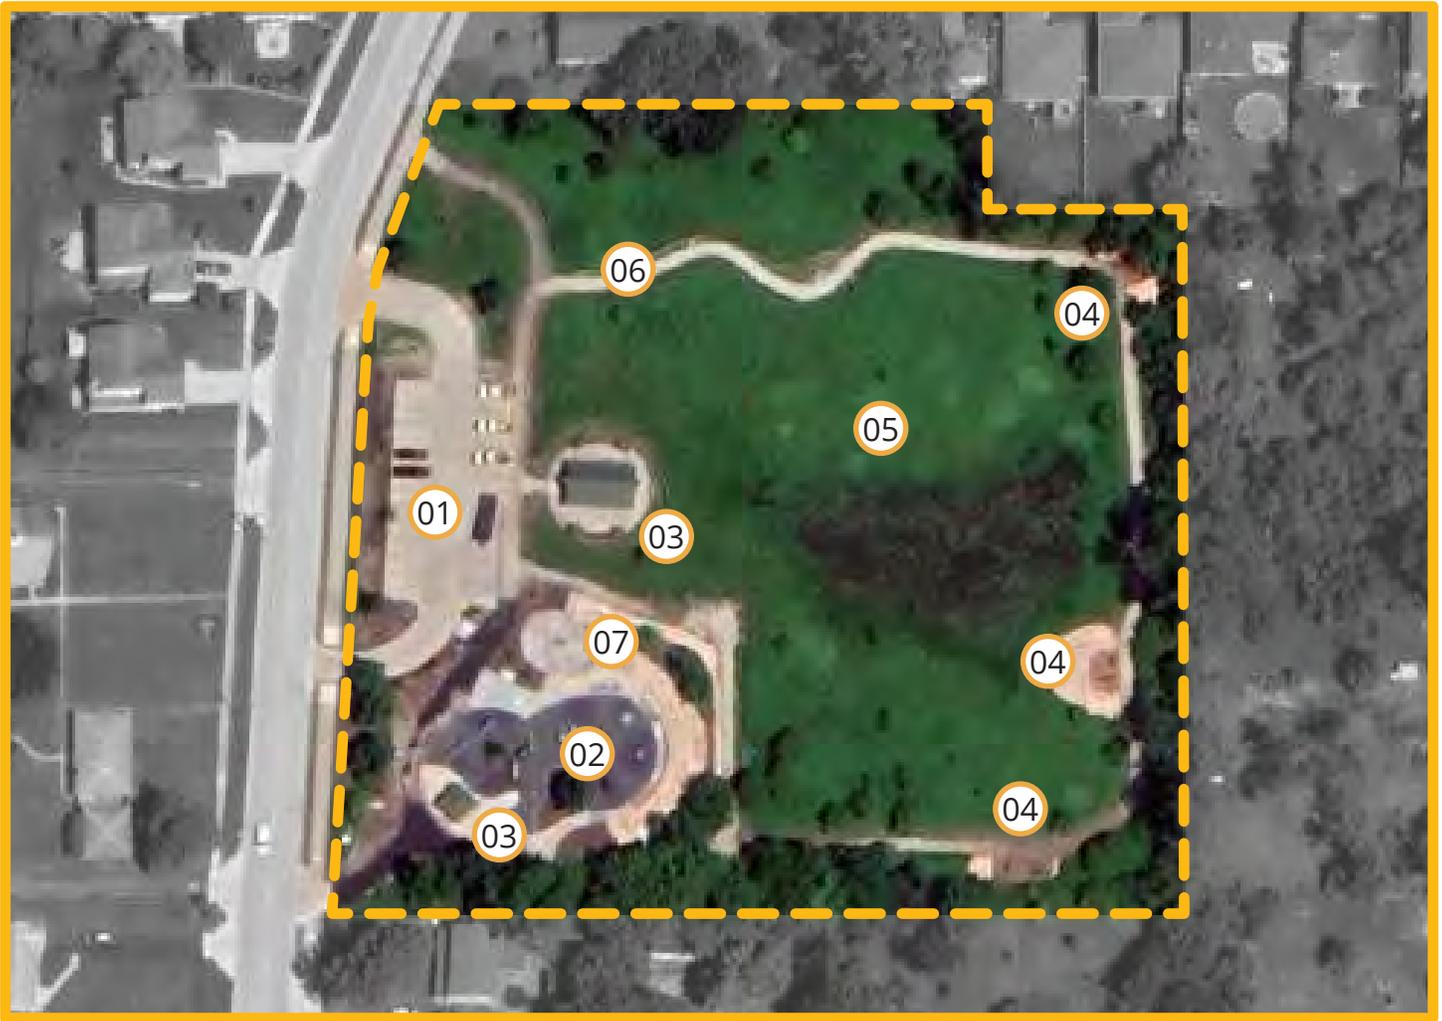
BREITER-PALM PARK

- 01 Parking Lot
- 02 Play Area
- 03 Shelter
- 04 Fitness Stations
- 05 Prairie
- 06 Limestone Path
- 07 Raised Planters

The play area includes poured-in-place rubber surfacing which is in excellent condition. The play area also includes a seat wall and concrete pavers which were recently installed.

The site has two existing shelters with lights that are in good condition.

The fitness stations are located along a crushed limestone path that encircles the park. The fitness stations are in excellent condition; however, the limestone path is in fair condition. There are areas of poor drainage which cause wash-out and the need for replenishment on an annual basis.

The park includes a stormwater/wetland area and prairie. Th native plantings are professionally managed and are in good condition. The turf areas are in good condition. The areas which were recently seeded in 2022 require over-seeding in order to achieve a healthy stand of turf.

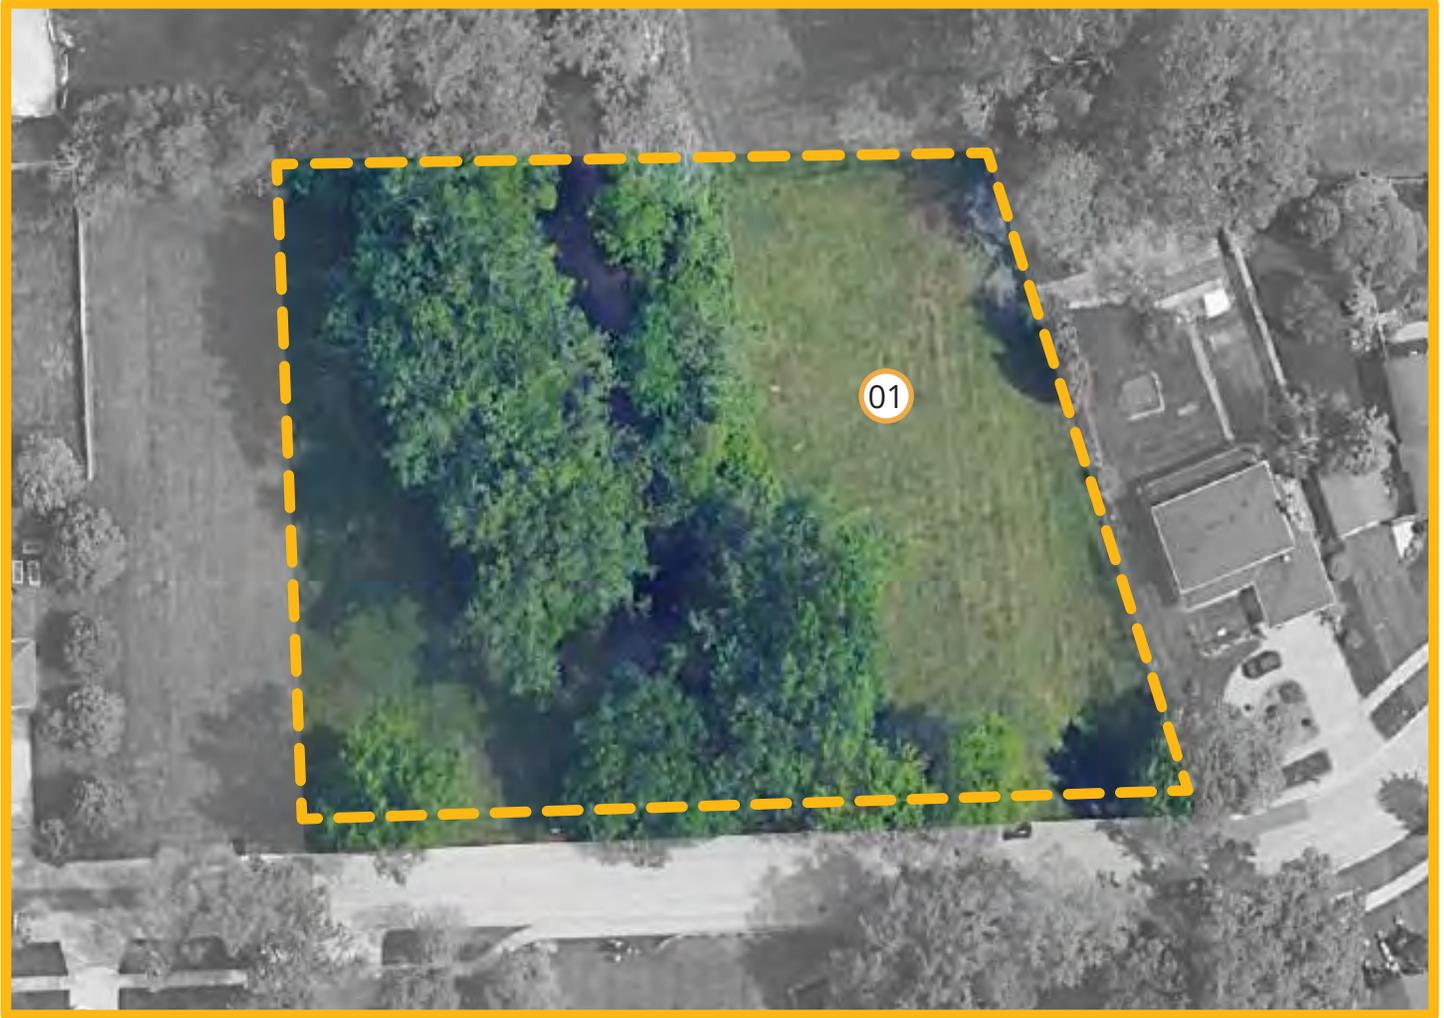
CREEKSIDE PARK

01 Open Space

Creekside Park is a 1.5-acre open space property within a residential neighborhood. Addison Creek runs through the center of the park and is lined with shade trees, providing dense shade in this area. For access to both sides of the park, residents must walk in the grass adjacent to the street to cross the bridge. The park includes a park sign, litter receptacle and picnic table on the west side along with an open turf area on both sides for drop in recreation. Park users can walk from the neighborhood or park on the street. The adjacent lot to the west is currently for sale.

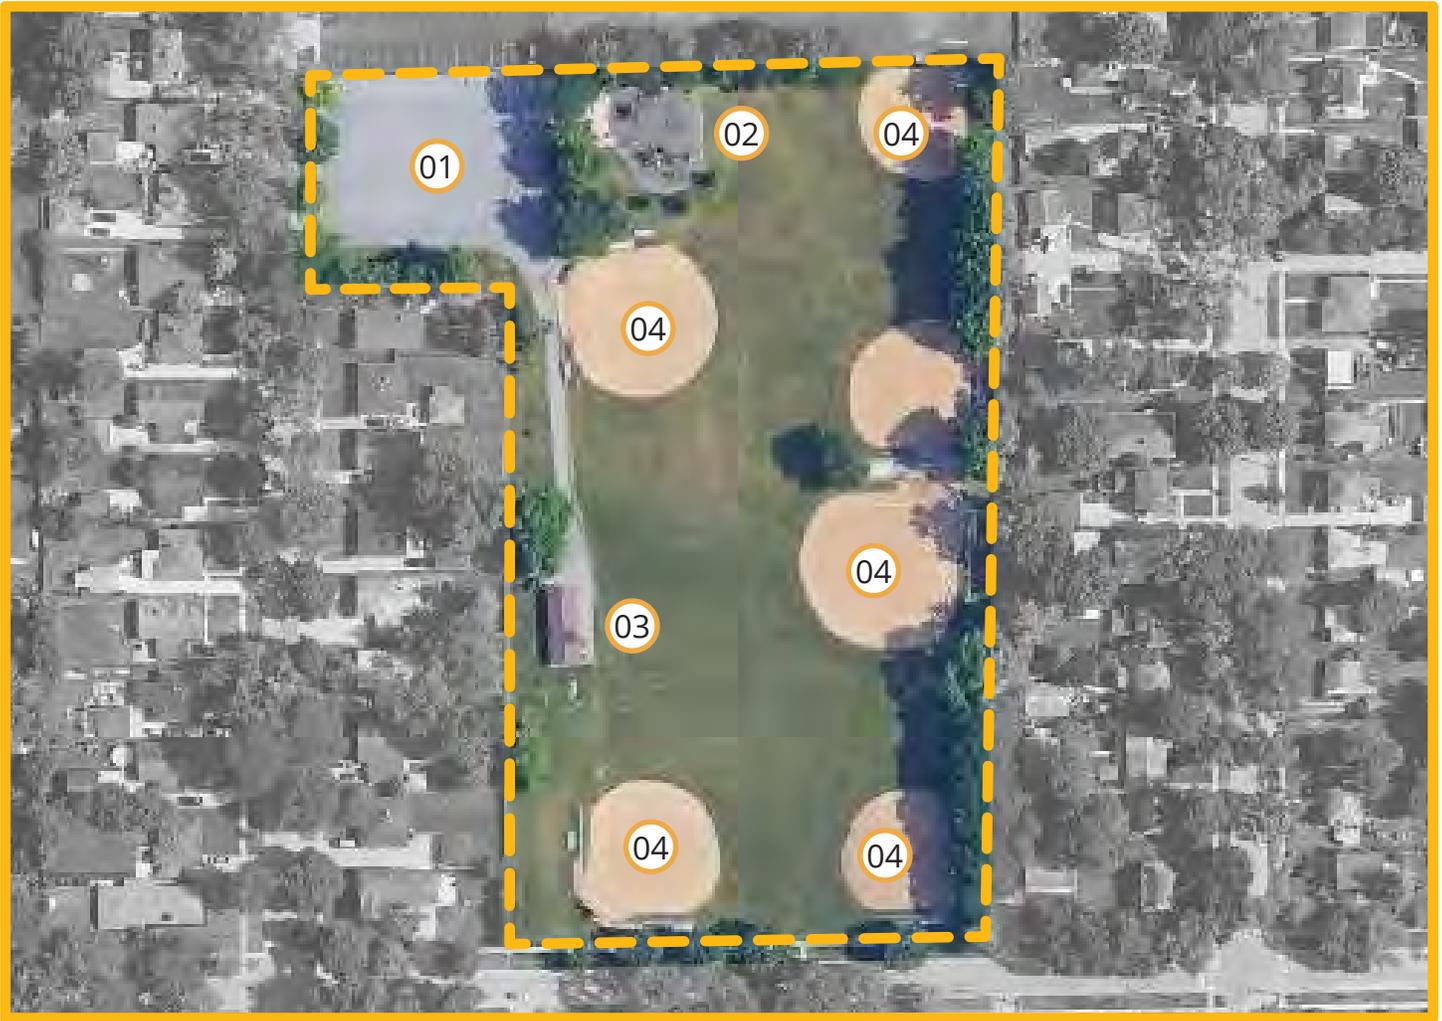
DiORIO PARK

- 01 Parking Lot
- 02 Play Area
- 03 Concessions Stand/Restroom Building
- 04 Softball/Baseball Field

The six fields vary in size, but all have skinned infields, backstops, player benches, and spectator seating. The fields are in good condition. The ballfield fencing and backstops are galvanized and in good condition. The player benches and bleachers are located within infield mix or set in the grass. They are in good condition; however, an accessible route is not provided.

The play area is accessible from the parking lot and is separated by a split-rail fence. There is a block retaining wall on the south side of the play area which creates an area for the entry plaza with benches, tables and litter receptacles. The wall and tables are in fair condition.

The play area is designed for 2-5 year old and 5-12 year old age groups. The equipment is in good to fair condition. The poured-in-place rubber surfacing has a few cracks and has been patched in areas. Underneath the swings are tile mats with a lot of wear. The concrete walks and curb are in good to fair condition.

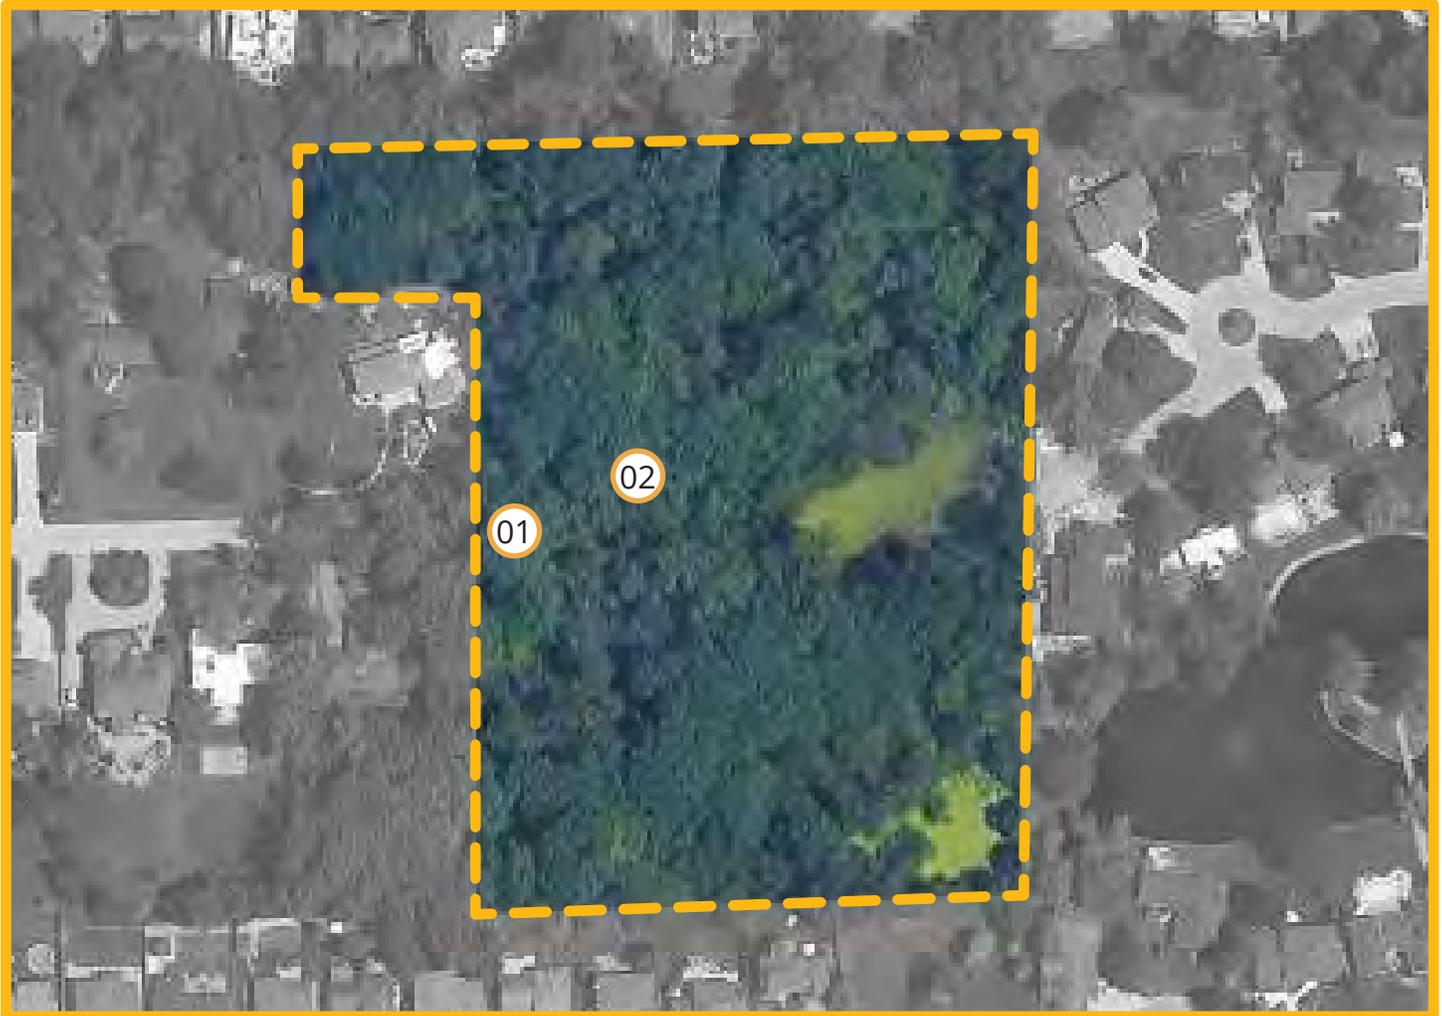
HYATT-HUBBARD PARK

376 TIOGA TRAIL, WOOD DALE

- 01 Parking Space
- 02 Mown Path

The park entrance is marked with a park sign and also has overhead utility lines (one is loose) and a

There is a vacant lot on the south border of Hyatt-Hubbard Park that is owned by the City of Wood Dale, which would be ideal for park access to both pedestrians and vehicles.

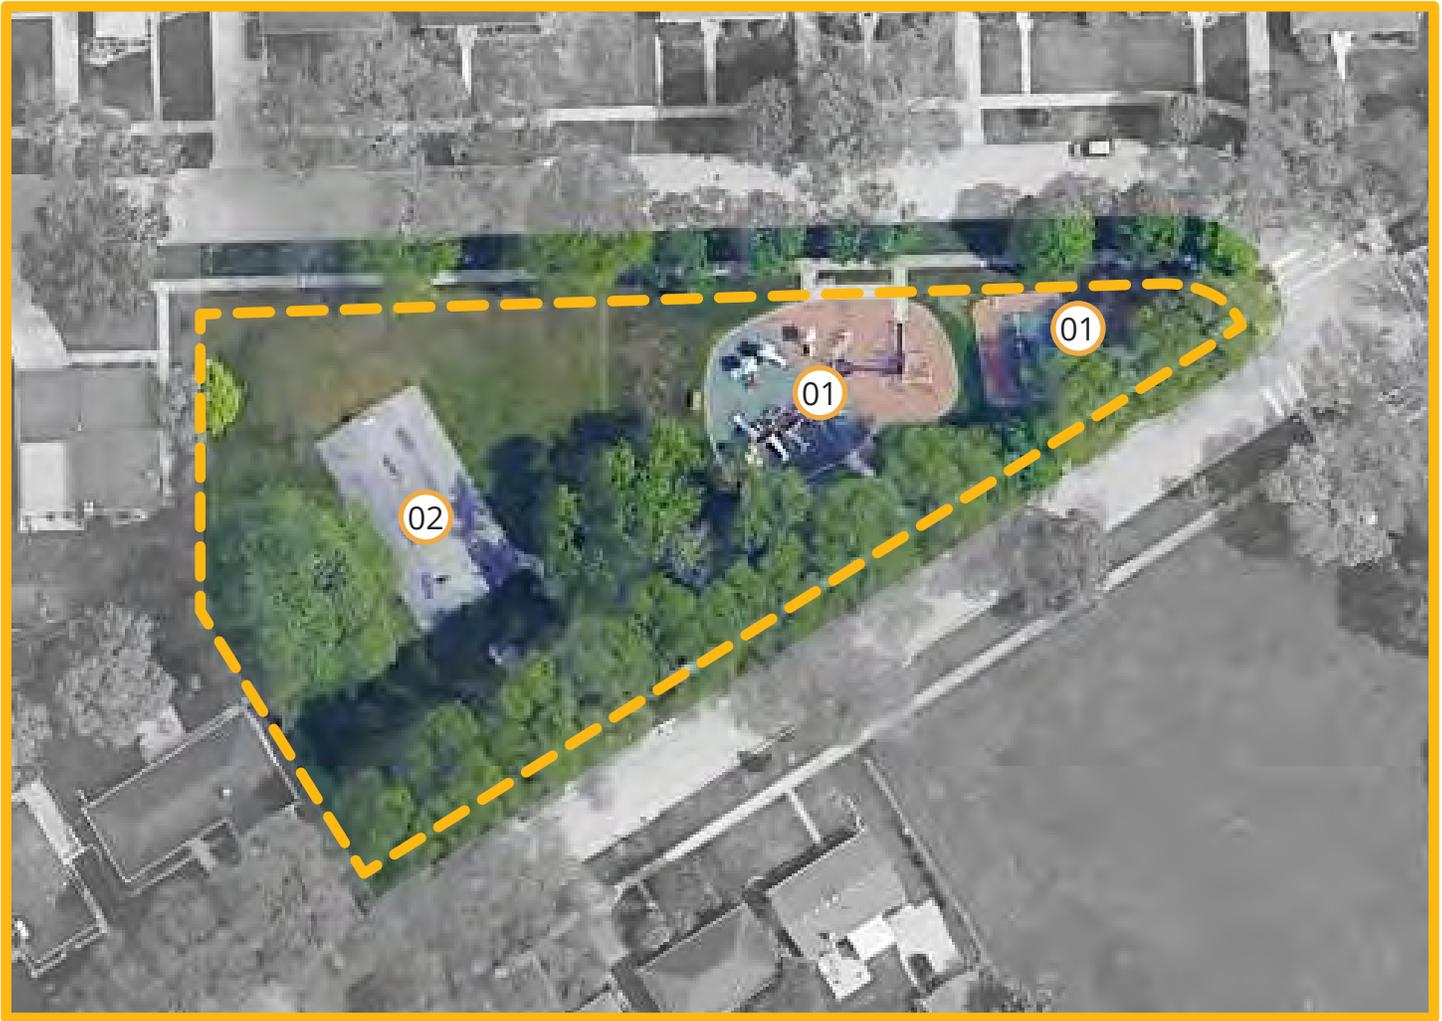
KREMPELS PARK

DENNIS DRIVE & JACQUELYN DRIVE, BENSENVILLE

- 01 Play Area
- 02 Basketball Court

The play area has three access points and the equipment provides areas for both 2-5 and 5-12 age groups and appears to be more than 15 years old. The 5-12 equipment provides full access for mobility devices with a ramp onto the structure. It also has a few broken pieces that should be immediately repaired. The equipment sits on a combination of engineered wood fiber and

The basketball court is in fair to poor condition with many cracks and patches in the asphalt surfacing. The line work is very faded and the color coat is non-existent. Both basketball standard footings are heaving. The court is accessible and has access from the sidewalk adjacent to Jacquelyn Drive.

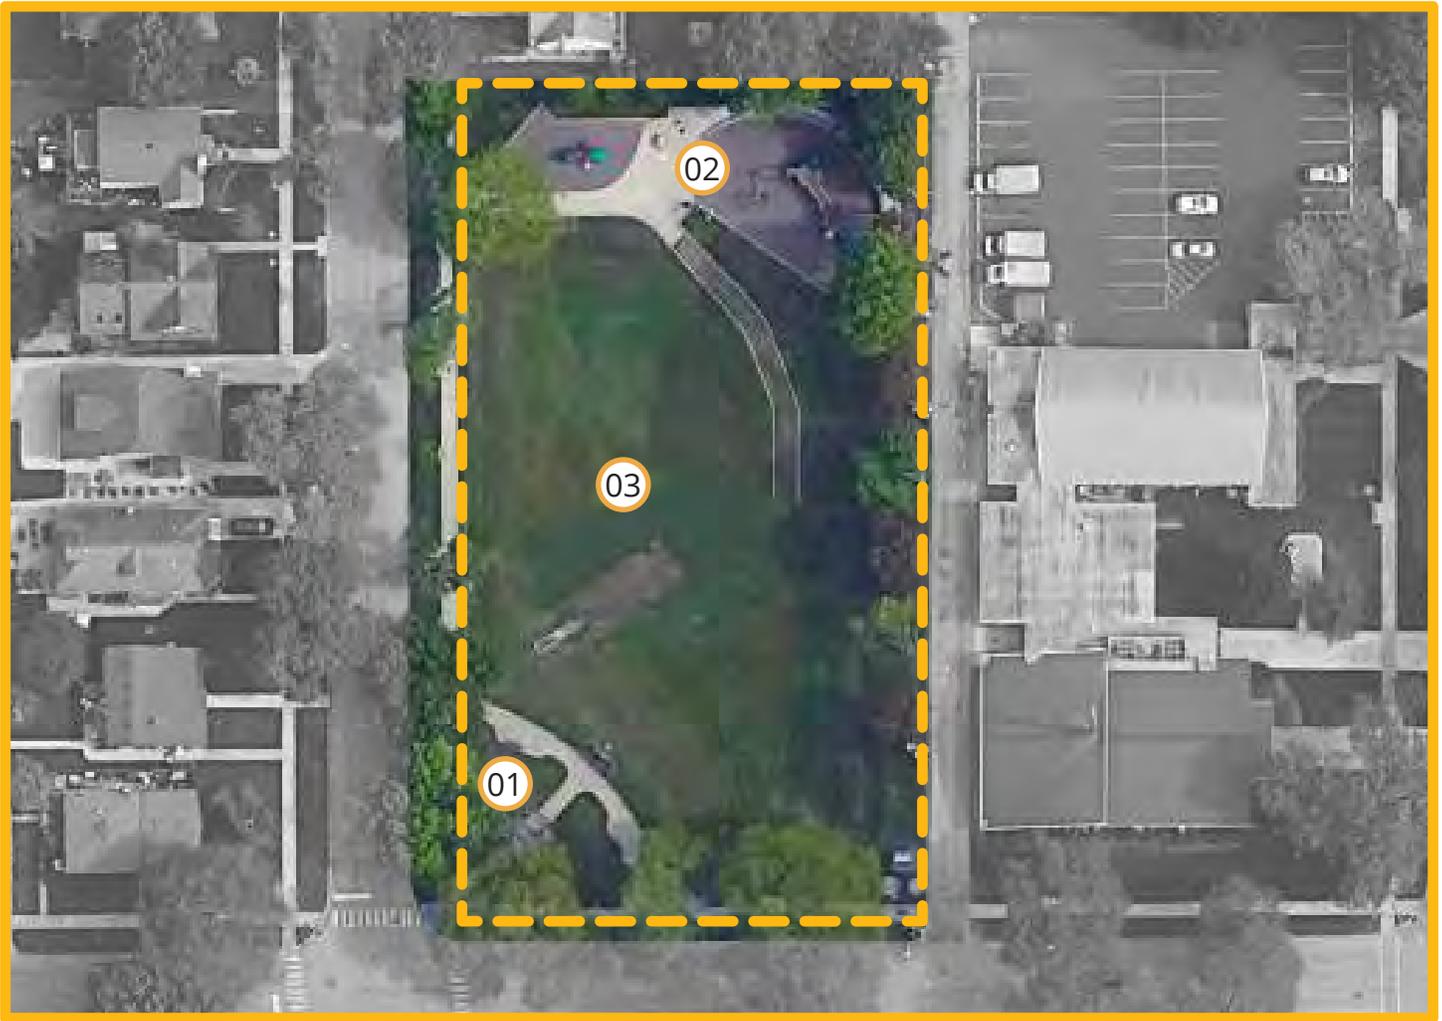
LIONS PARK

192 S CENTER STREET, BENSENVILLE

- 01 Entry Feature
- 02 Play Area
- 03 Stormwater Basin

The southwest corner of the park includes an entry feature with a small wooden pergola, which is in fair condition. The plaza includes benches and a park sign. This area overlooks the stormwater basin.

On the north side of the park is a play area for 2-5 and 5-12 age groups. The play equipment is in fair condition and is beyond its expected useful life. The pre-cast block retaining wall is in good to fair condition.

The play area includes poured-in-place rubber surfacing. The surfacing is in good to fair condition with a few areas of cracking. A low spot exists in the southeast corner of the 5-12 area where the poured-in-place rubber surfacing has experienced extreme wear. Water was seen pooling during the site visit.

The stormwater outlet in the southeast corner is covered by a grate, but the outlet in the southwest corner has only a partial grate and could be accessed by small children.

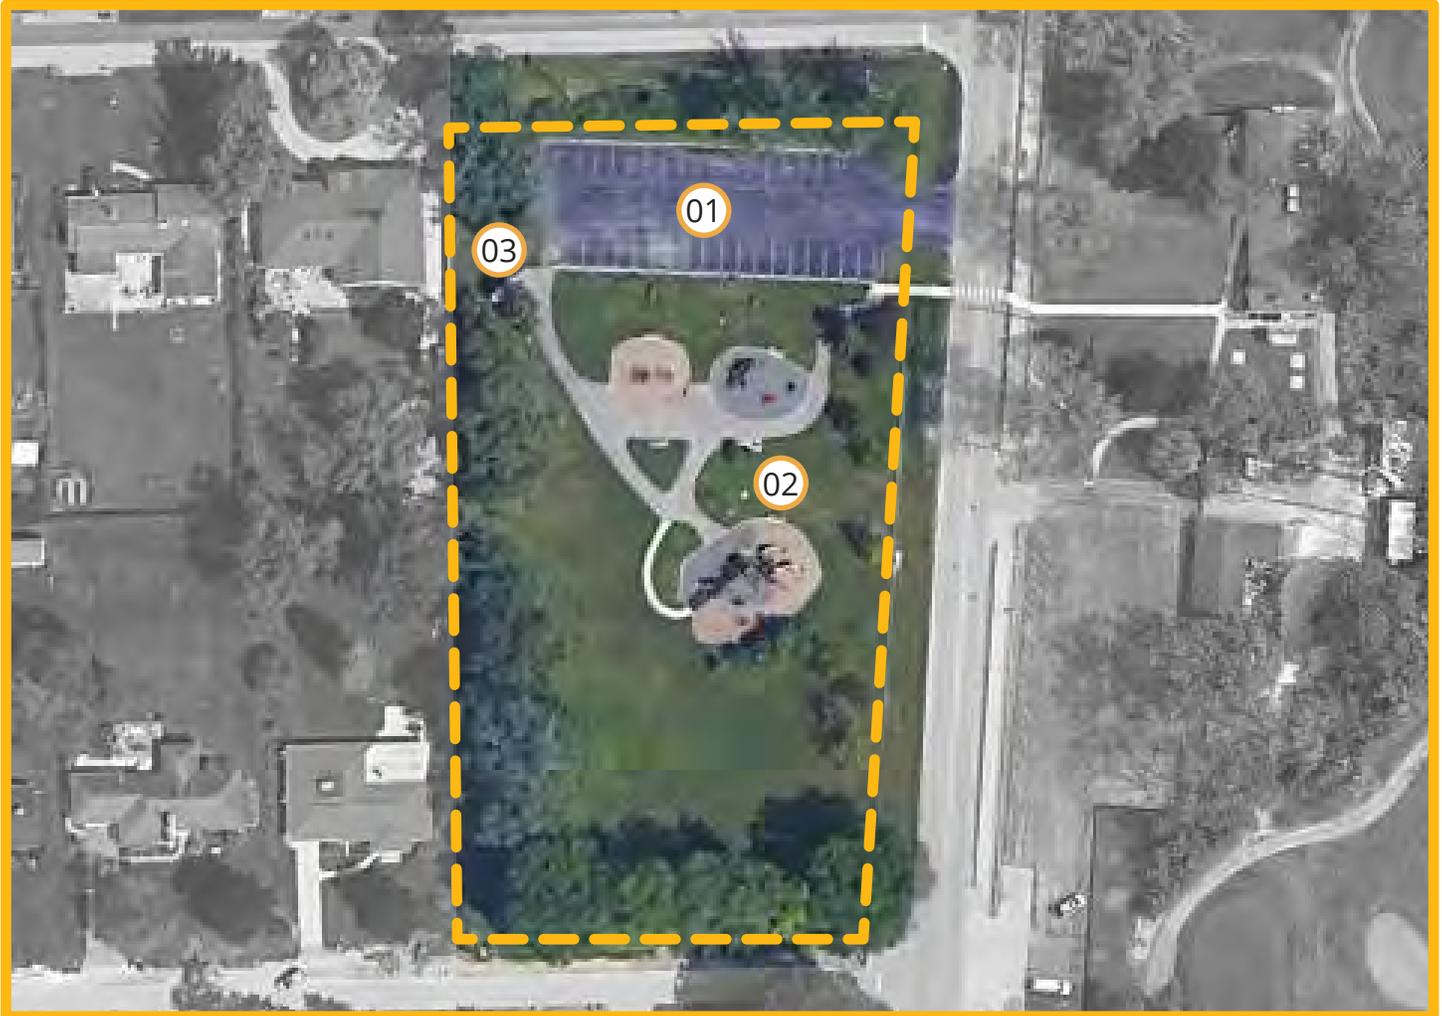
PINES PARK

Legend:

- 01 Parking Lot
- 02 Play Area
- 03 Port-a-Pottie

The parking lot is in fair condition with many cracks and the striping is fading. The asphalt and concrete path network are in good condition and lead to all park elements; however, the swings area is not accessible, as there is no ramp into the engineered wood fiber mulch surface.

The play equipment was manufactured in 2008 and is in good condition, but is beyond its useful life. The 2-5 structure and spring riders are

located on poured-in-place rubber surfacing that has many cracks and is in fair condition.

The 5-12 structure is located on both engineered wood fiber and poured-in-place surfacing. The poured-in-place rubber surfacing has many cracks and is in fair condition. The 5-12 structure has a ramp that allows users with mobility devices to wheel directly onto the structure.

The existing port-a-pottie has a wood screen that is in fair condition.

The prairie and lawn are both in good condition. A few dead trees are marked for removal.

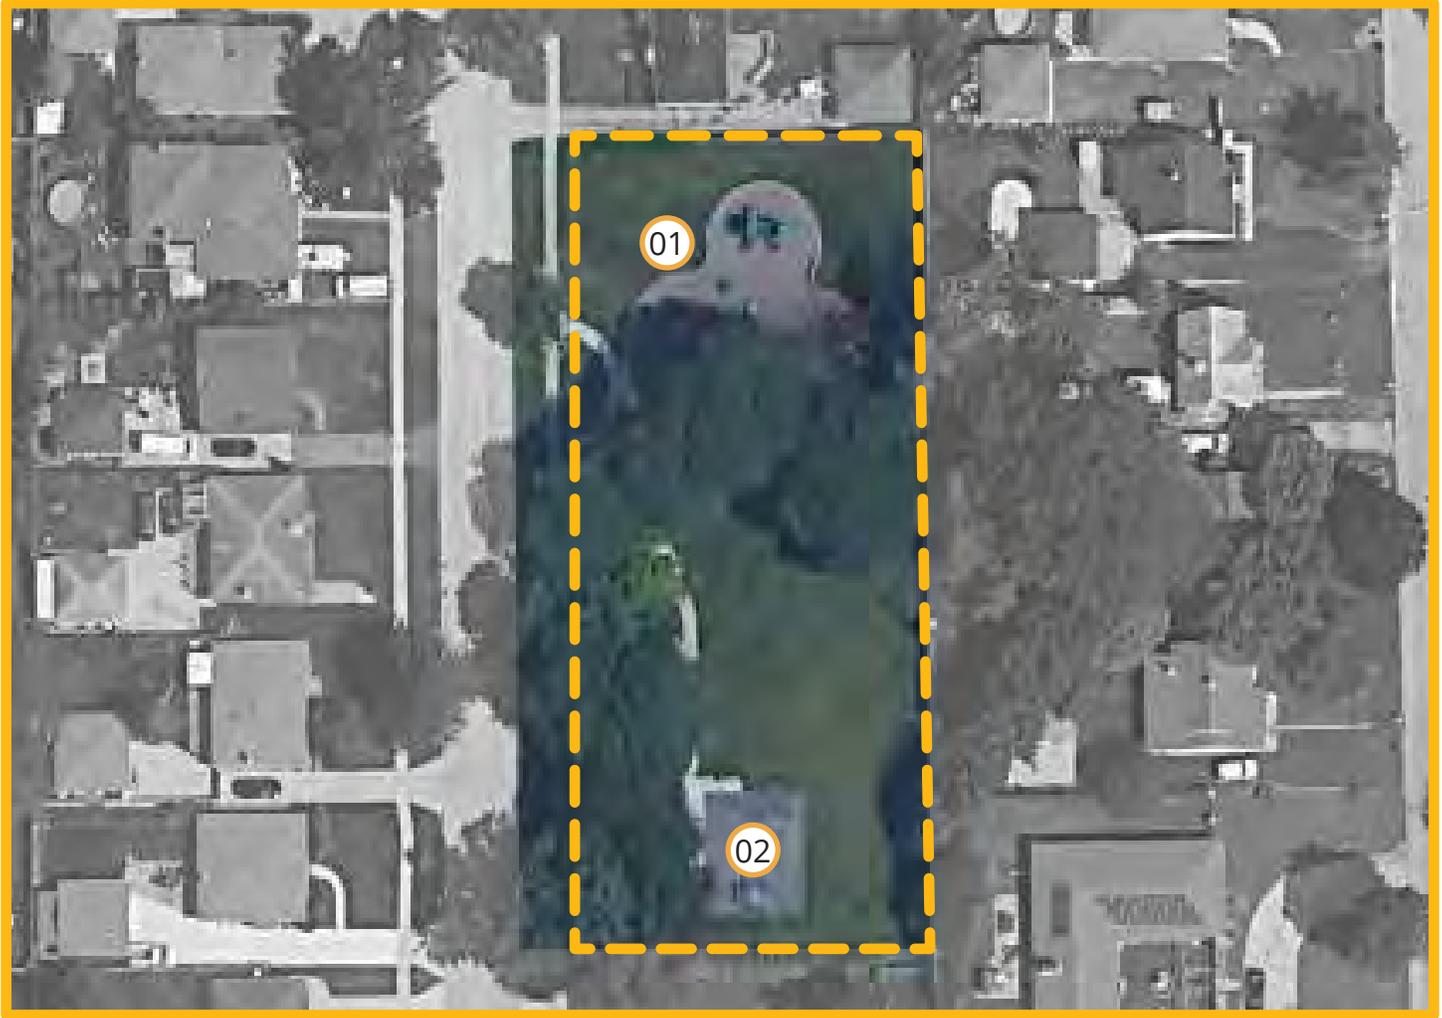
POPLAR PARK

Legend:

- 01 Play Area
- 02 Basketball Court

The north and east sides include a mix of wood and chain link fencing and a row of evergreen shrubs along the south property line. The park contains mature trees which provide shade for the play area and half-court basketball. The trees, shrubs, and lawn are in good condition.

The internal concrete path network is in very good condition and links all park elements.

The half court basketball asphalt surfacing is in good condition; however the line-work is faded.

There is a bench and 3-seat table adjacent to the court. The site furnishings are in good condition.

The play area provides elements for both the 2-5 and 5-12 year old age groups. The entire play area is poured-in-place rubber surfacing, which is in good condition. The equipment appears to be newer and in very good condition. The seat wall along the play area is in good condition.

There are two park signs on site. One is the new Park District standard.

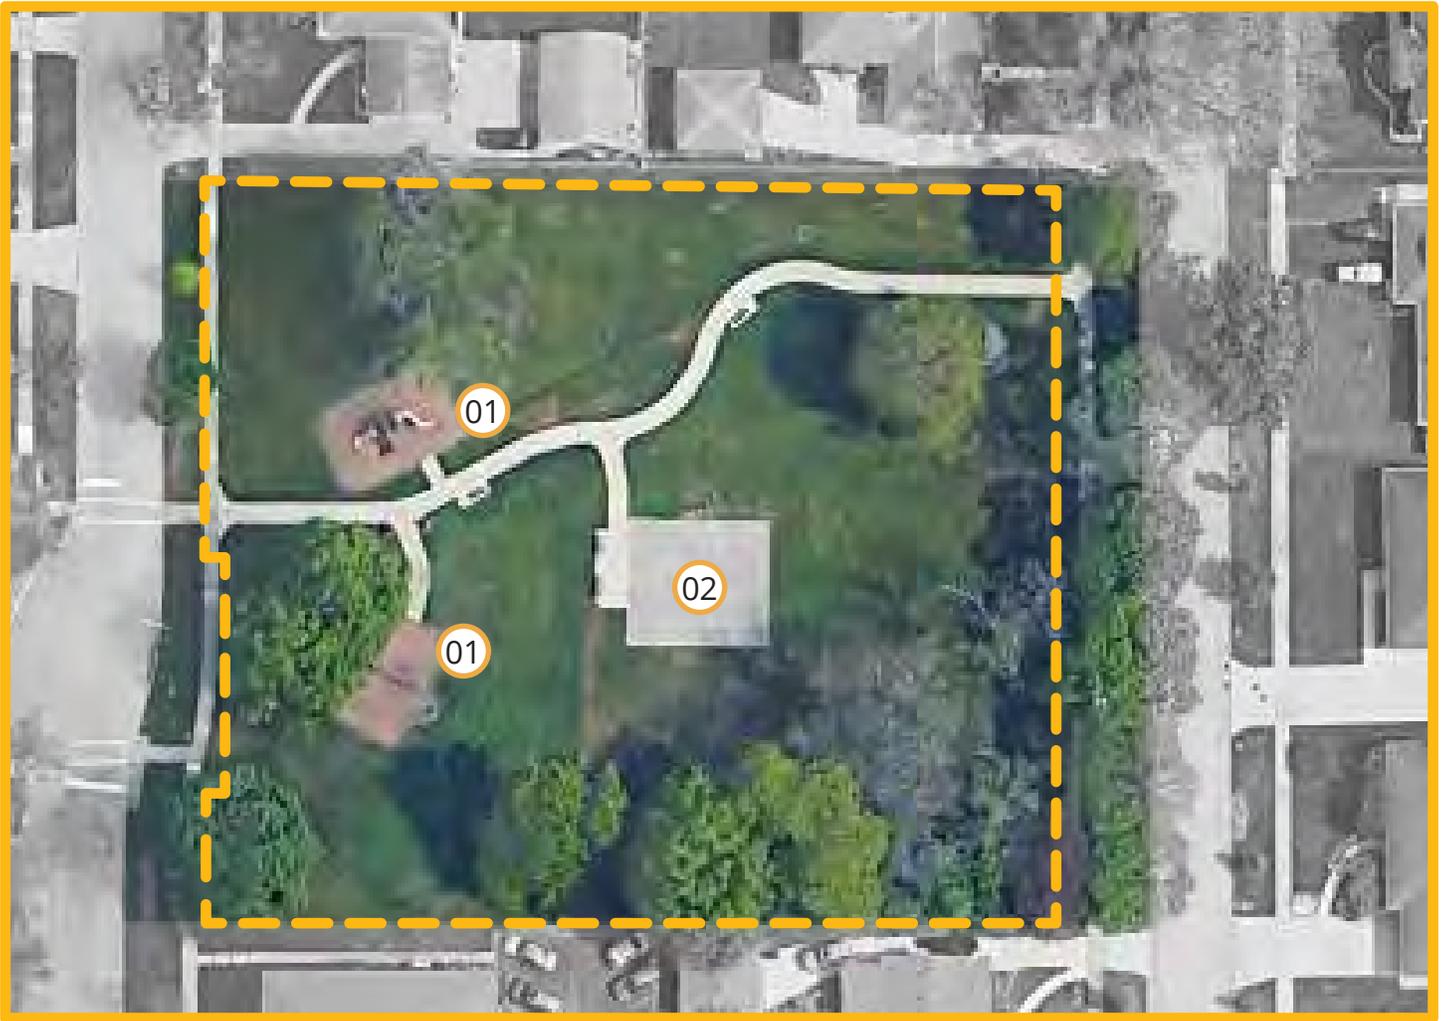
ROSE PARK

Legend:

- 01 Play Area
- 02 Basketball Court

Rose Park is a 1.3-acre park adjacent to single-family and multi-family residential homes with on-street parking. The park has clear sight lines from David Drive to Daniel Drive and provides a larger expanse of open space with mature trees within the neighborhood. The trees and lawn area are in good condition.

The concrete walk within the park connects to both sidewalks on the east and west sides and is in great condition.

The half-court basketball court is in fair condition. The asphalt pavement is cracking and the line work is faded.

The site furnishings are in good to fair condition. The benches are in good condition; however, the 55 gallon drum litter receptacles are rusting and dented. The park sign does not match the current Park District standard.

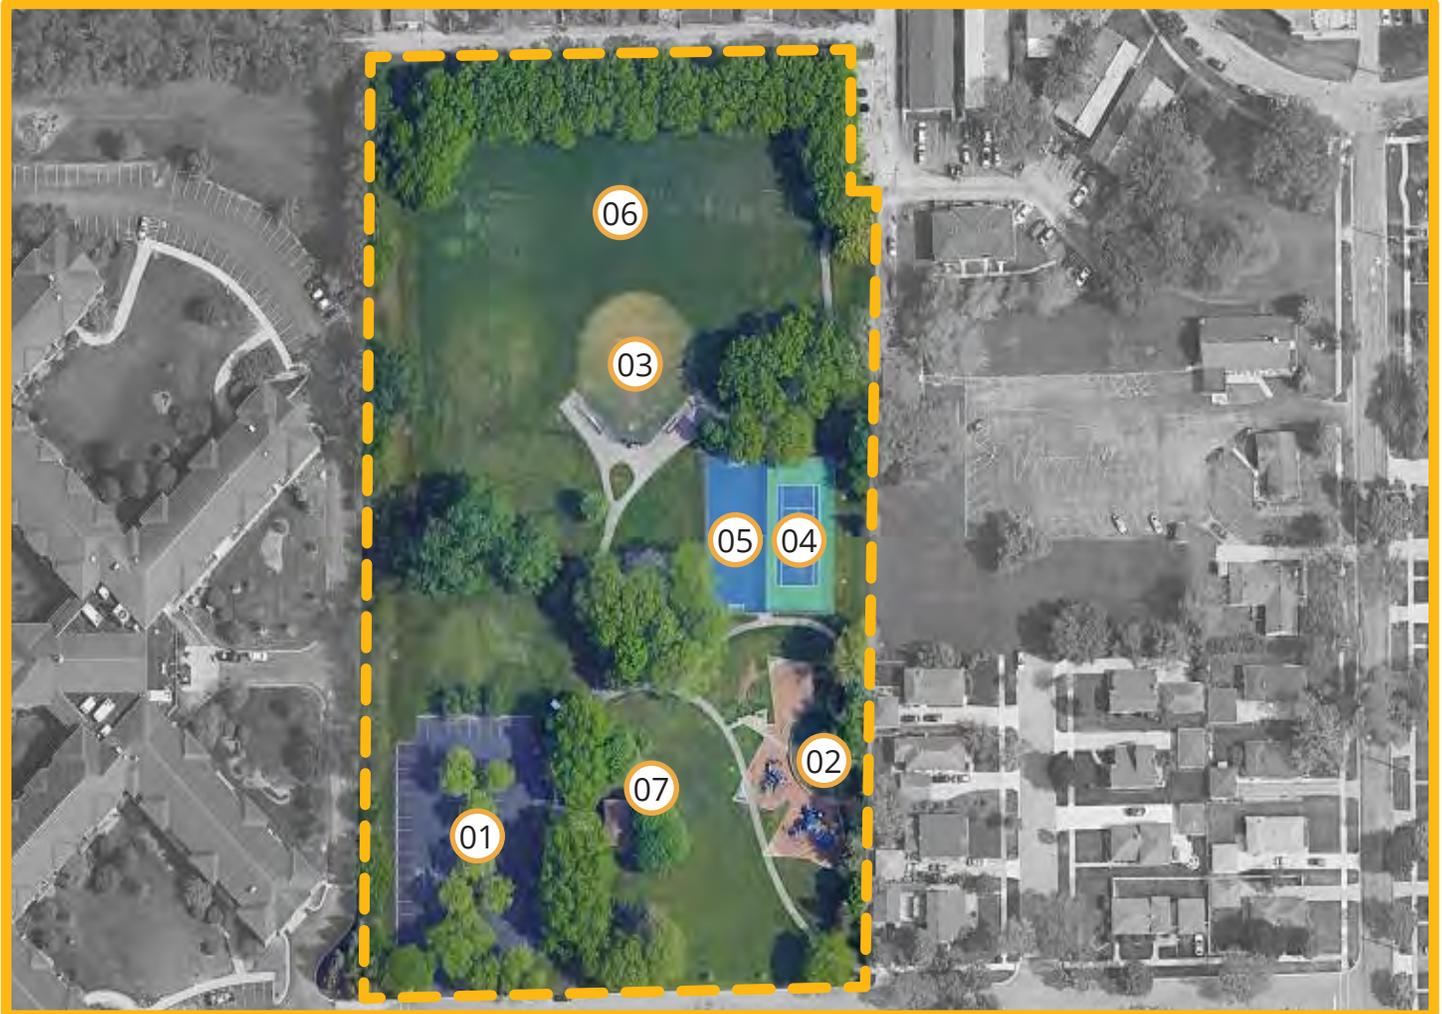
SUNRISE PARK

MARION STREET & MEMORIAL STREET, BENSENVILLE

- 01 Parking Lot
- 02 Play Area
- 03 Baseball Field
- 04 Tennis Court
- 05 Roller Hockey Court
- 06 Soccer Field
- 07 Shelter

The park provides off-street parking in the southwest corner of the park. The asphalt parking lot is in good condition with visible striping and parking blocks in place.

The soccer field is located on the north side of the park. The field and turf are in good condition.

The baseball field has a backstop, player bench areas, equipment storage and a grass infield. Spectator seating is not provided; however, there is an area for bag chairs. The player benches have graffiti on them and the bench footings are heaving. The backstop and fencing are in fair condition, as some of the fabric is pulling away from the rails.

The tennis and roller hockey court asphalt pavement has cracks throughout; however, the color coat acrylic surface is new and in excellent condition. The galvanized fencing and gates are in fair condition. The fence is rusting and the footings are starting to heave. The tennis courts were provided through the Addison Township Revenue Sharing Fund in 1975. The roller hockey courts appear to have had graffiti in areas due to the color coating being repainted white.

The play area offers equipment for ages 2-5 and 5-12 with an engineered wood fiber surfacing. The equipment is dated and past its useful life. The play areas do not include an ADA access; however, it appears the intent was to keep the engineered wood fiber mulch flush with the asphalt path and concrete bands surrounding the play area. The concrete pavers are sunken in some locations, and the concrete band is a trip hazard to enter some of the play area. The paver area connection with the asphalt path is not flush and is a tripping hazard for mobility device users. Each of the paver areas contains a circular engraved stone with references to sun gods in different cultures. The block wall surrounding the

play area has started to shift and loosen over time. East of the play area there is a concrete circle with lawn in the center. From research of historical aerials, it appears this area may have contained a seating area or sun dial with plantings. There are several benches and tables surrounding the play area which are in good condition.

The shelter is wood with asphalt shingles and four round tables underneath. The shelter is in good to fair condition. The concrete pad is in good condition. North of the shelter is an ADA port-a-pottie located off of an asphalt path. The asphalt path network throughout the park is in fair condition with many cracks and weeds growing through the pavement.

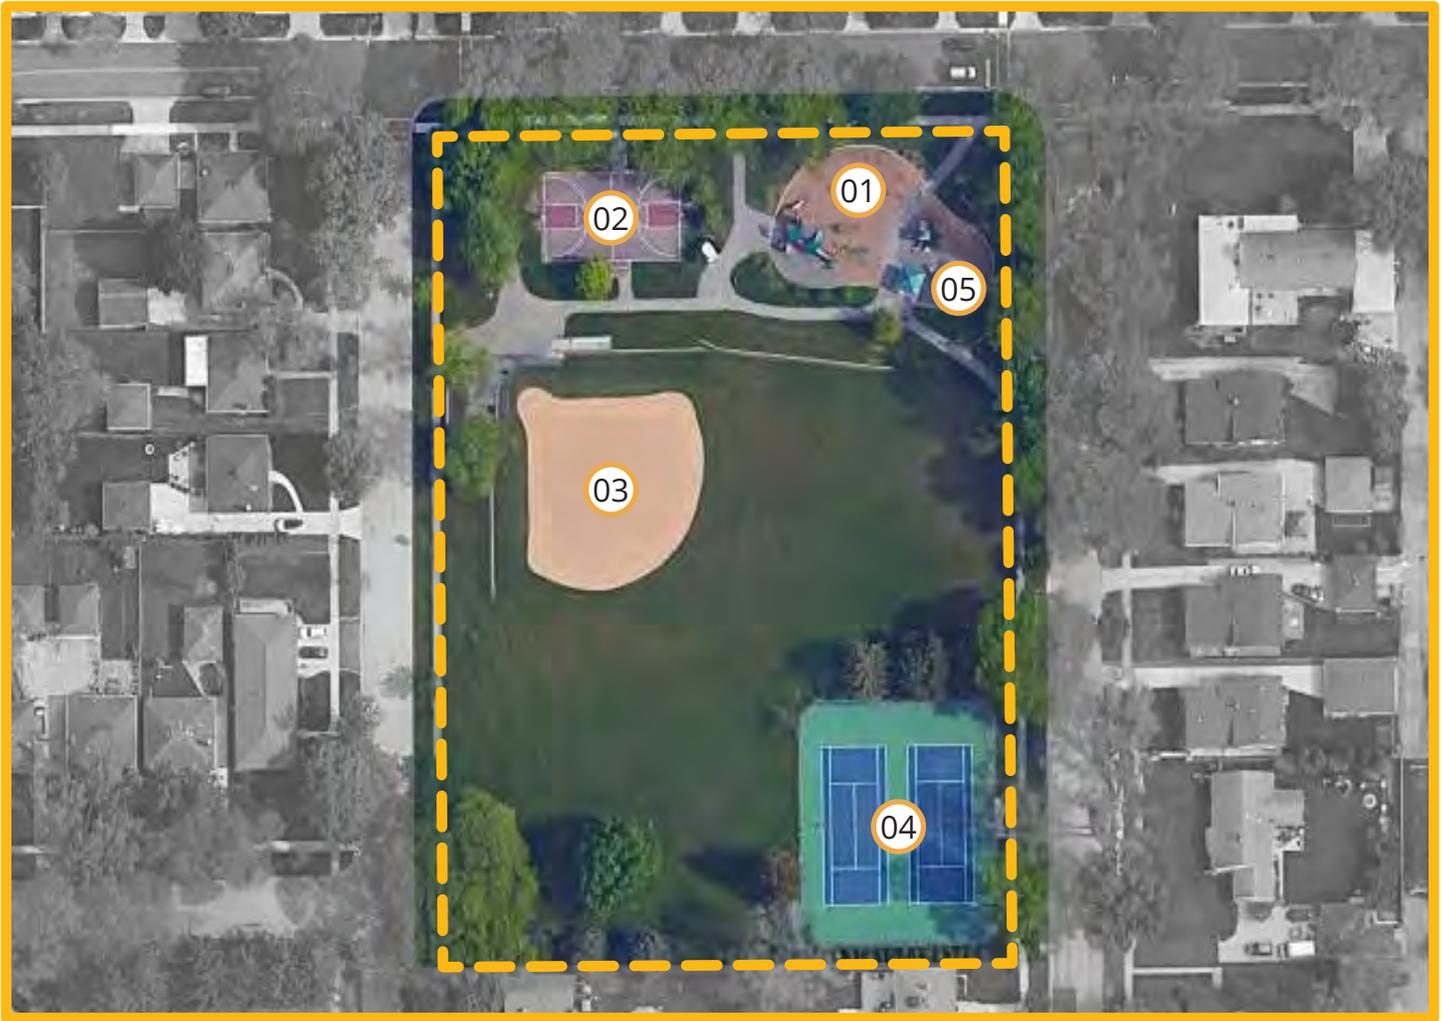
SUNSET PARK

GROVE AVENUE & SUNSET STREET, BENSENVILLE

- 01 Play Area
- 02 Basketball Court
- 03 Baseball Field
- 04 Tennis Court
- 05 Shelter

There are several pre-cast block walls adjacent to the play area and court; the walls are in good condition.

The basketball court is in fair condition. The asphalt pavement is cracking the color coating has faded. The court line work appears to be new. There is one five-row stand of bleachers on the

The ADA port-a-pottie is located between the basketball court and play area and is screened by a wooden enclosure with peeling stain. The enclosure is in fair to poor condition.

The play area offers equipment for 2-5 and 5-12 age groups with a combination of engineered wood fiber mulch and poured-in-place rubber surfacing. The play equipment is in good condition. The poured-in-place rubber surfacing has several cracks in both the swings/2-5 area and 5-12 area. It is also separating from the edge in some locations. Access into the areas with engineered wood fiber mulch are flush with the existing asphalt path.

A small metal shelter with one 4-seat table is adjacent to the 2-5 play area and is in good condition.

The tennis courts have large cracks down the center and the tennis net posts and fencing posts are heaving. Both courts have newer acrylic color coat surfacing and striping. There is a bang wall which is in good condition in the northwest corner. The courts are located at the south property line next to single-family homes and are screened on the north and south by evergreens and arborvitaes.

The baseball field is in good condition including the skinned infield, galvanized fencing, player benches and backstop. It is orientated in position two, which is one of the better positions for play.

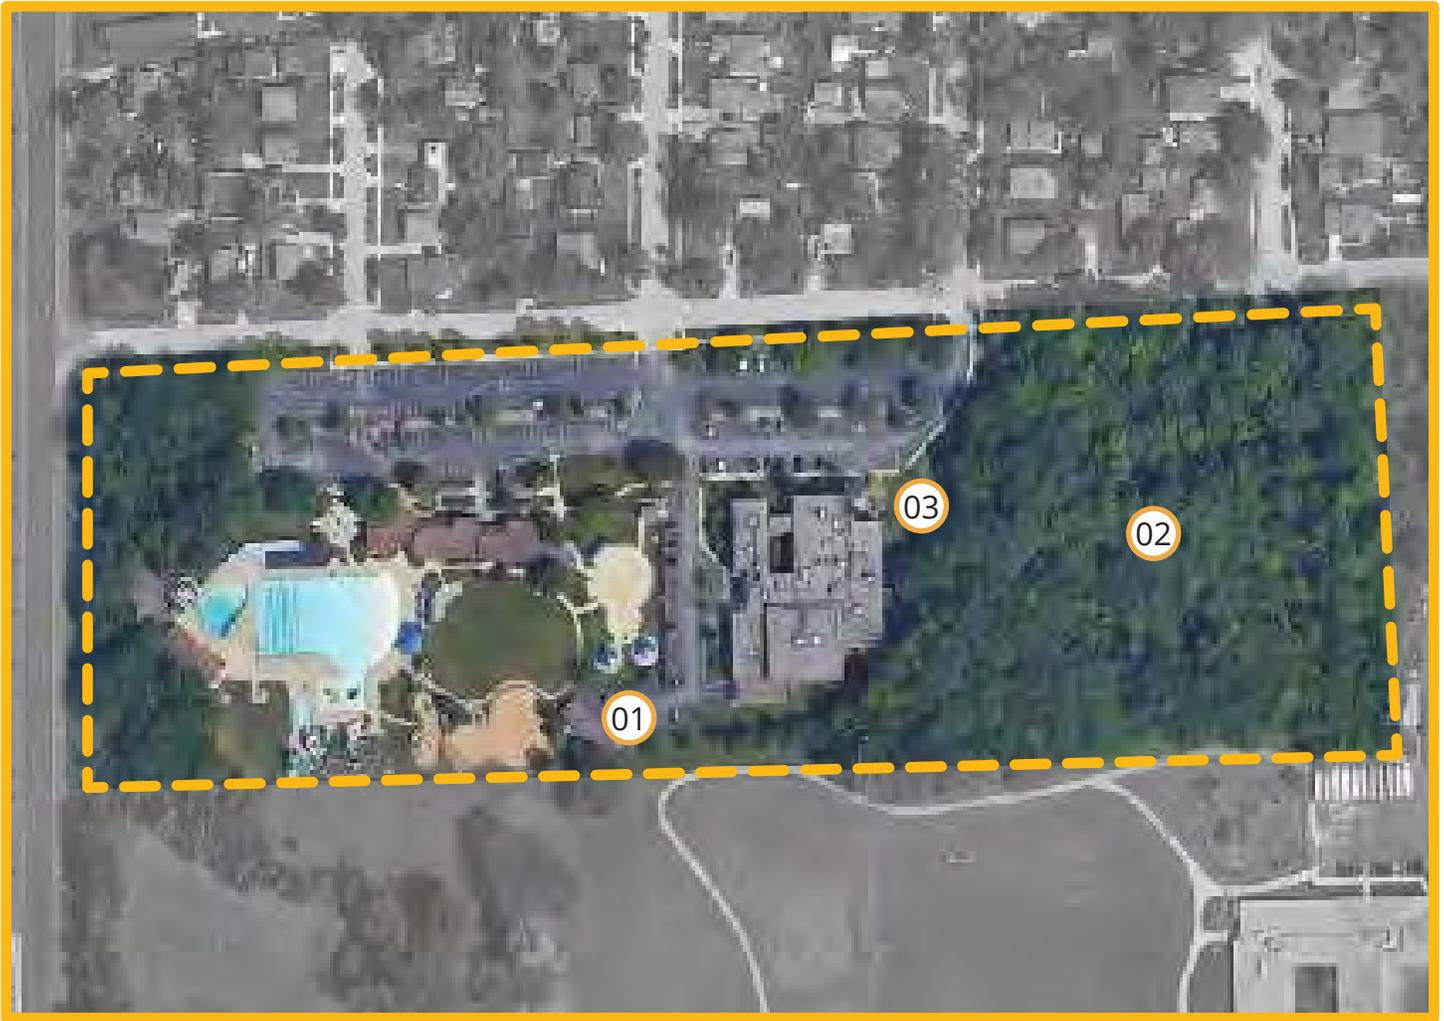
VARBLE PARK

1000 W. WOOD STREET, BENSENVILLE

Legend:

- 01 Shelter/Concessions Building
- 02 Woodland Path
- 03 Playground

receptacles. The site furnishings are in good to fair condition. The concrete is cracking in the picnic area, as well as at the northern area of the concessions staging.

There is a small playground at the northeast corner of the Deer Grove Leisure Center for ages 5-12 with poured-in-place rubber surfacing. The play equipment and surfacing are both in good condition.

The play area is fully accessible from the parking lot and building. There is a seating area with benches and a 4-seat table adjacent to the play area. The site furnishings are in good to fair condition.

Conditions Assessment	
Curb Appeal	Good
Pedestrian Access	Good
Internal Access	Good
Playground	Good
Lawns	Good
Landscaping	Good
Concessions/ Restroom Building	Good to Fair
Shelter	Good to Fair
Park Sign	Fair
Site Furnishings	Good to Fair
Maintenance	Good
