2023 Bensenville Park District Facilities Assessment

Bensenville
Park District

Executive Summary

The JSD Professional Services Team, which includes TRIA Architecture, was commissioned by the Bensenville Park District to conduct an assessment of their parks and buildings. The report includes the assessments of each of the 17 park sites, and the buildings associated with the Deer Grove Leisure Center, White Pines Golf Club, Water Park & Splash Pad Bathhouse, and the Buildings & Grounds Maintenance Facility.

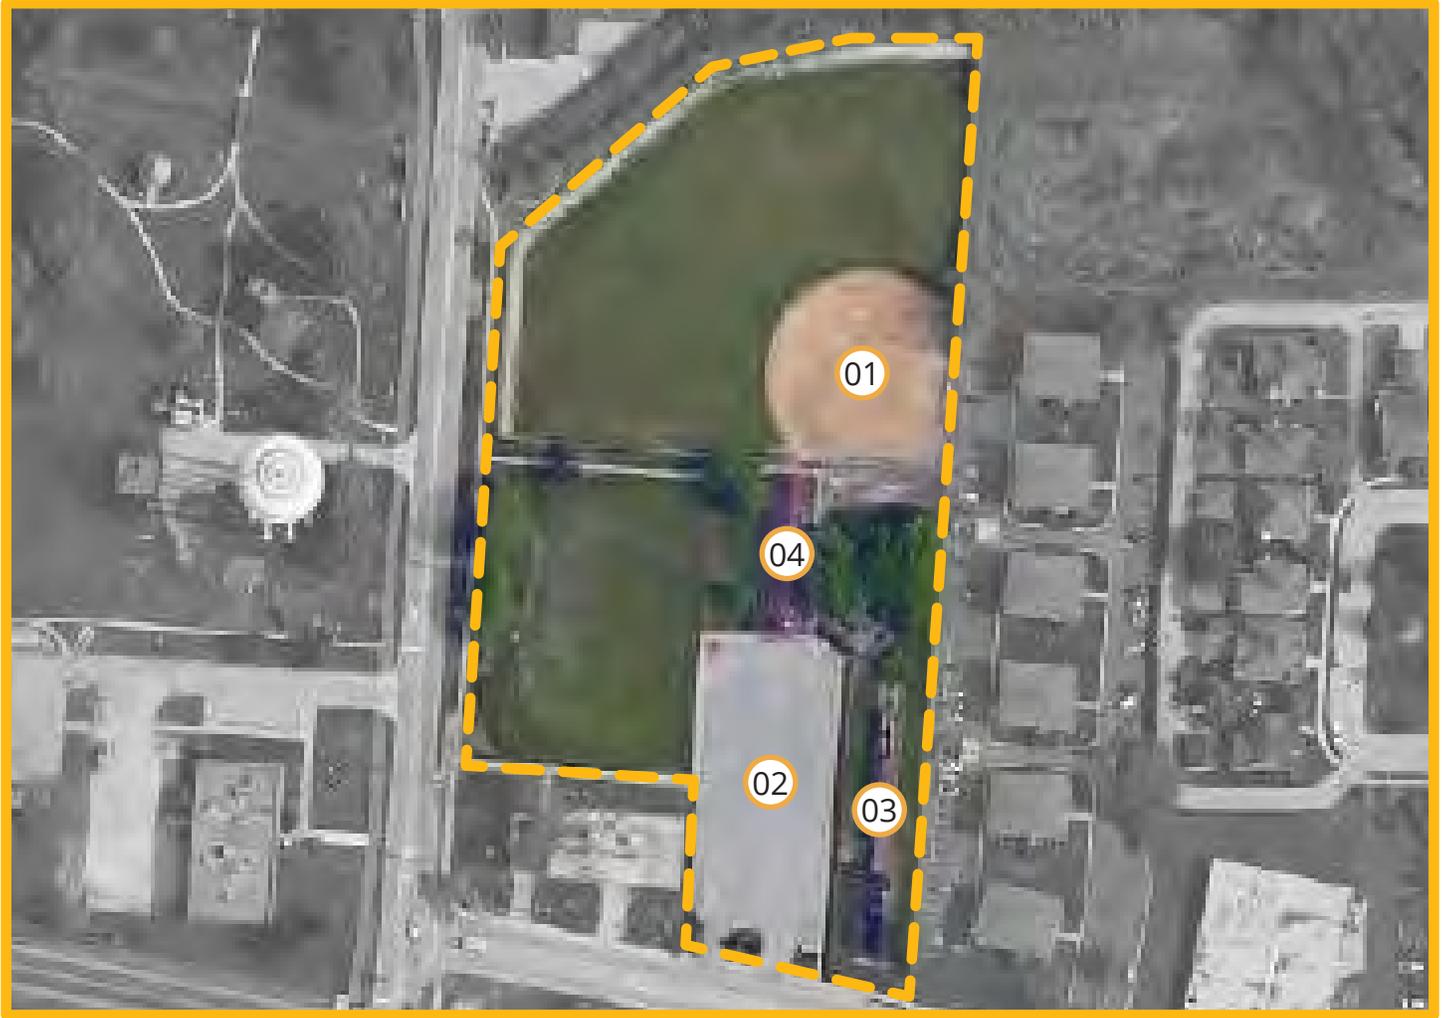
VETERANS PARK

MAIN STREET & N. CHURCH ROAD, BENSENVILLE

Legend:

- 01 Baseball Field
- 02 Parking Lot
- 03 Train
- 04 Building

The parking lot pavement has a few cracks but has recently been seal-coated and re-striped and is in good condition.

The concrete sidewalk adjacent to the parking lot is in good condition but the concrete around the existing park building has many cracks and is in

fair to poor condition.

The lit ballfield is contained by a six-foot and eight-foot high galvanized fence with a locked gate and is for use only by permit. The fence is worn, warped, many footings are popping, and it is in fair to poor condition. The field is in fair condition with many weeds growing in the infield. The bleachers are set on dirt and grass and are inaccessible for mobility users.

The park sign is the old design standard and is in fair condition.

On the east side of the park is the train museum consisting of several locomotives within a 10-foot high fenced area and building. There is a variety of railroad tie walls with concrete pavers. This area is uninviting to visitors and is in fair condition.

In the central green space west of the parking lot is a turf stormwater area that holds water.

Conditions Assessment	
Curb Appeal	Good
Pedestrian Access	Good
Internal Access	Fair
Train Engine	Good to Fair
Lawns	Good
Landscaping	Fair
Baseball Field	Fair
Parking Lot	Good
Building	Fair
Park Sign	Fair
Site Furnishings	Fair
Maintenance	Good

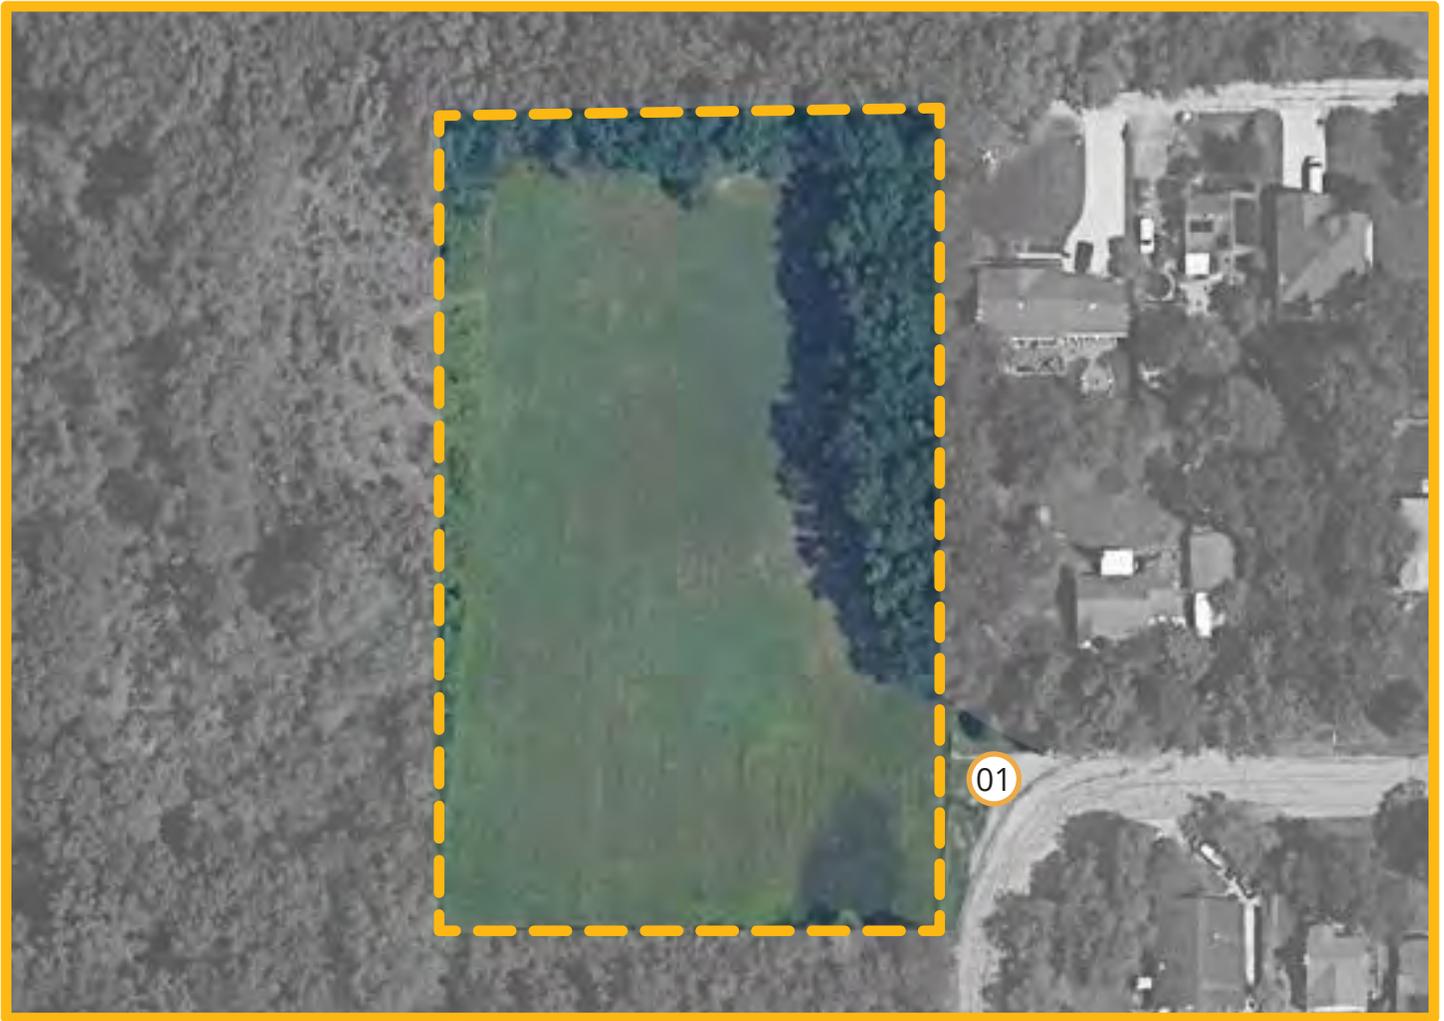
WOODCREST PARK

01 Parking Area

Woodcrest Park is a 2-acre undeveloped park in the City of Addison surrounded on three sides by the Forest Preserve District of DuPage County; to the east are single family homes.

There is a gravel area to park two cars at the park entry. The park entrance has a wooden fence in fair condition, a rusty metal gate, wooden bench and litter receptacle. The park sign is in good condition. There is also pedestrian access from Crest Avenue. The adjacent wooded areas are a beautiful backdrop for a park.

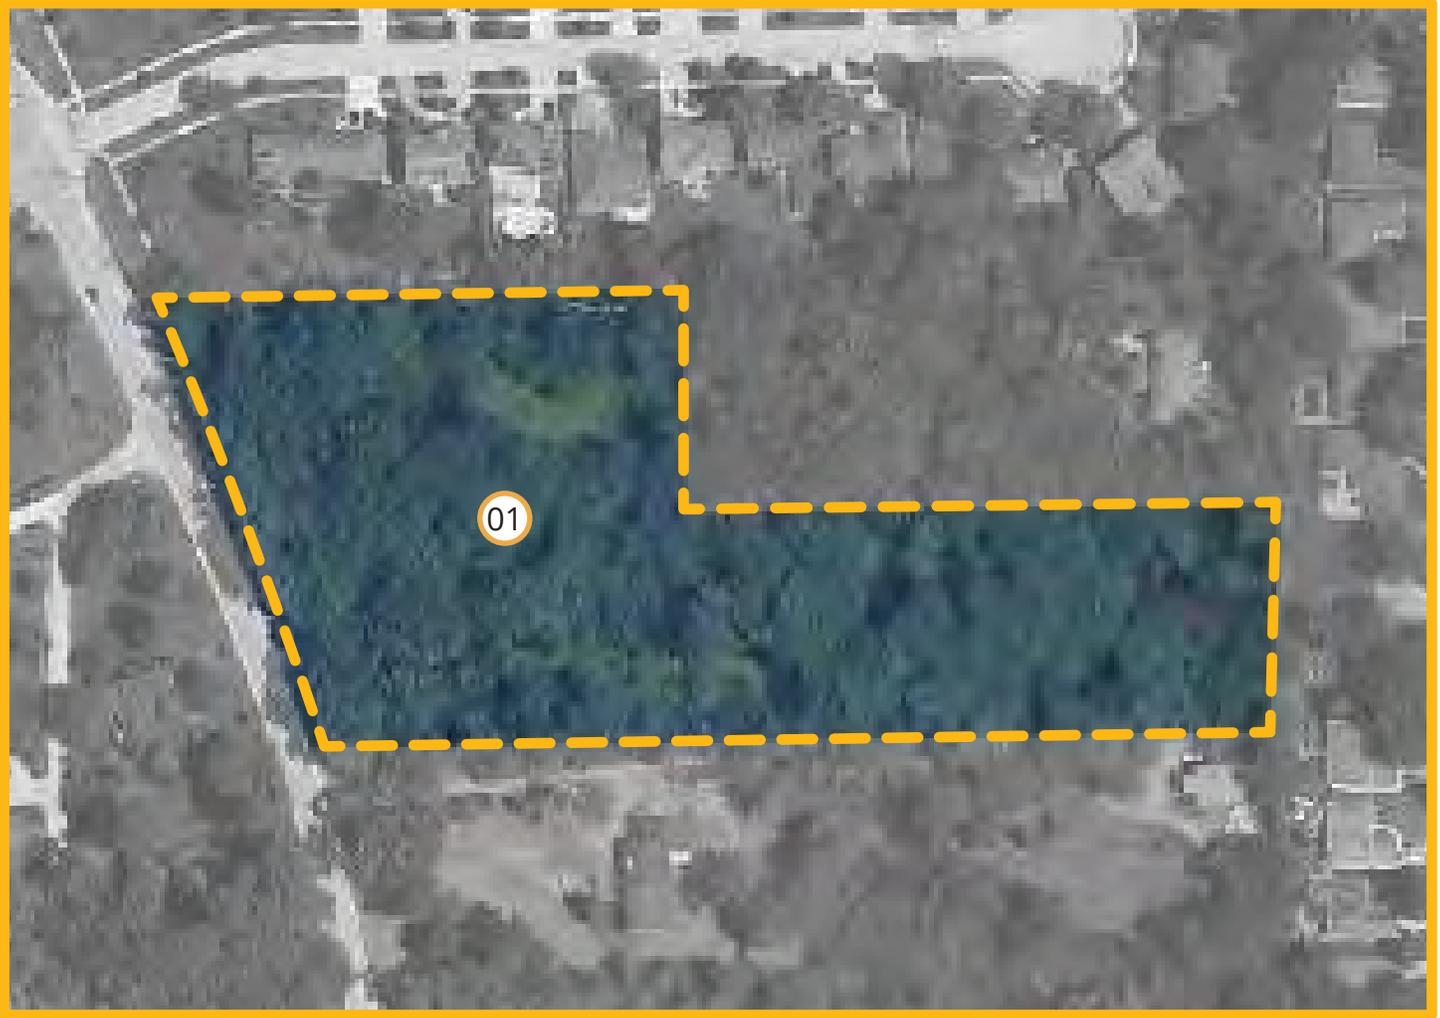
WOODLAND AREA

01 Woodland

Woodland Area is a 5.5-acre property within Wood Dale city limits.

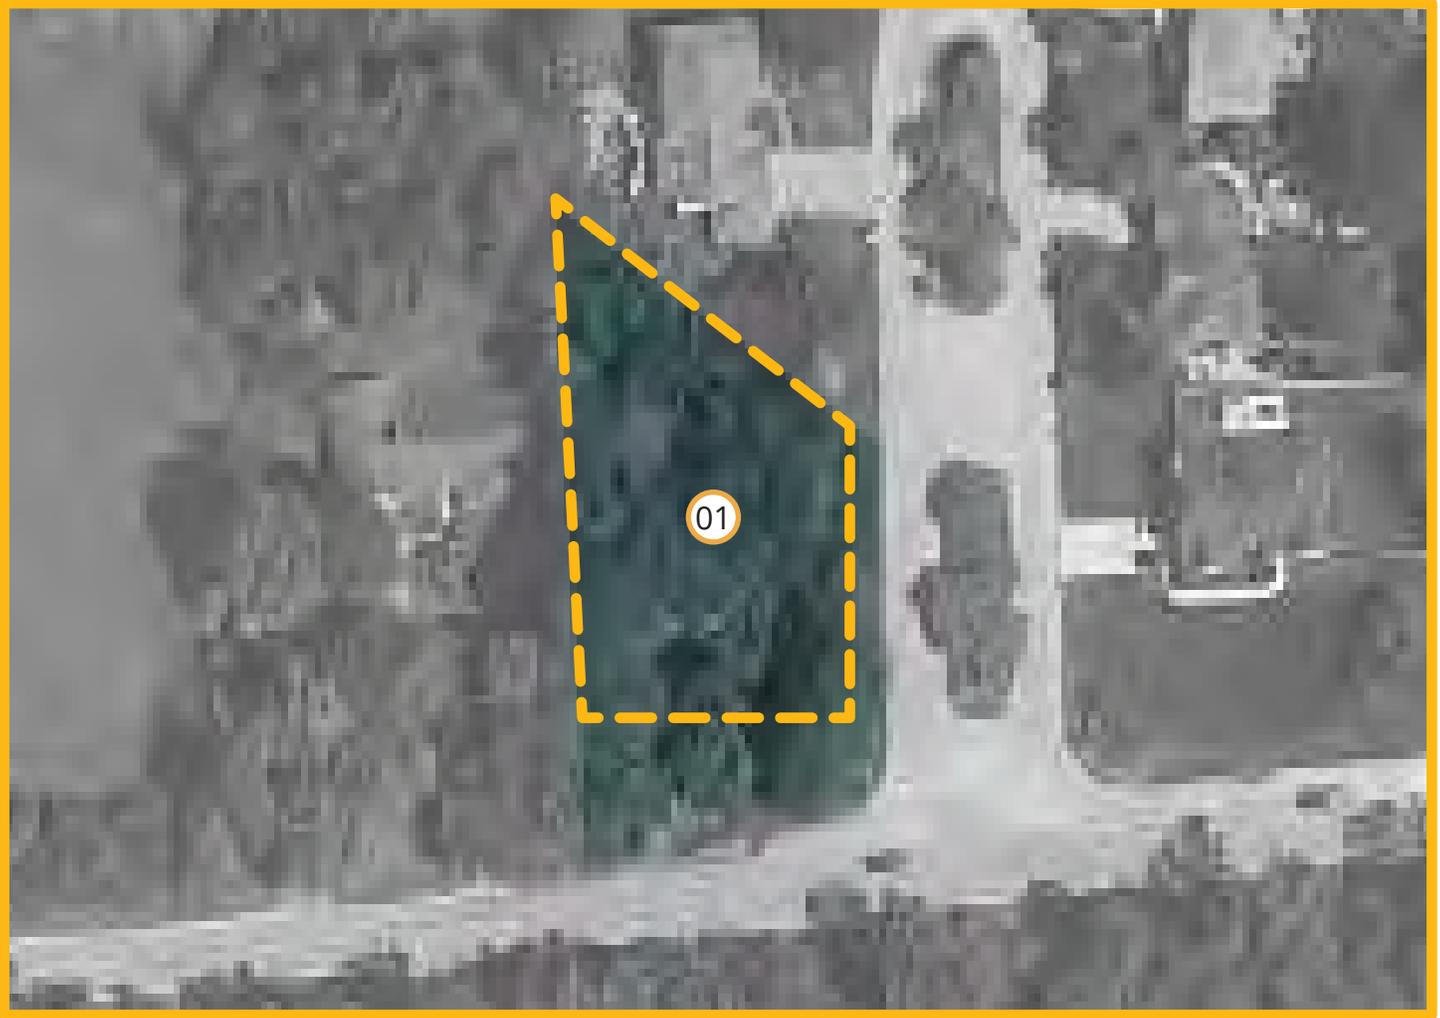
WOODSIDE PARK

01 Woodland

Woodside Park is a 0.5-acre undeveloped, wooded park in the City of Addison.

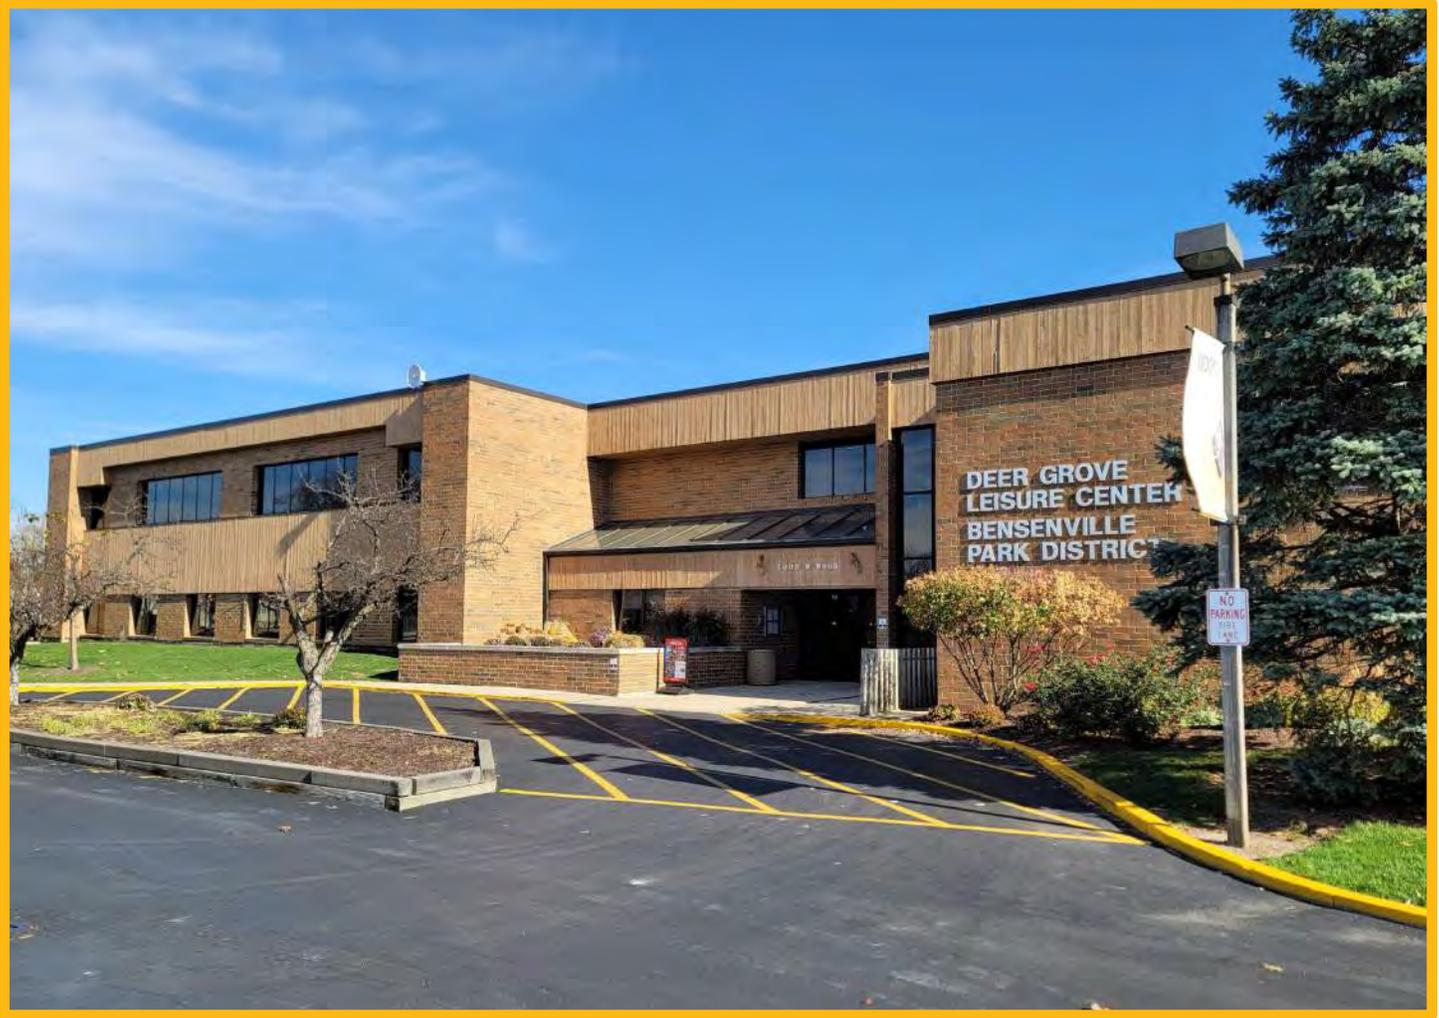
DEER GROVE LEISURE CENTER

The Deer Grove Leisure Center houses the Park District offices as well as several activities spaces including a pre-school, gymnasium, fitness areas, arts and crafts spaces, and a Senior Center. The building is generally in good condition but does require some repairs and upgrades.

The wood siding on the exterior is worn and either needs to be refinished or replaced. The ballasted EPDM roof over the majority of the building appears to be in good condition but there are a few areas where leaks are noted that need to be repaired. Especially above the second floor Dance Room where the room must be closed during rain events due to the leaks in the

roof. The shingle roof over the garage is worn and needs to be replaced.

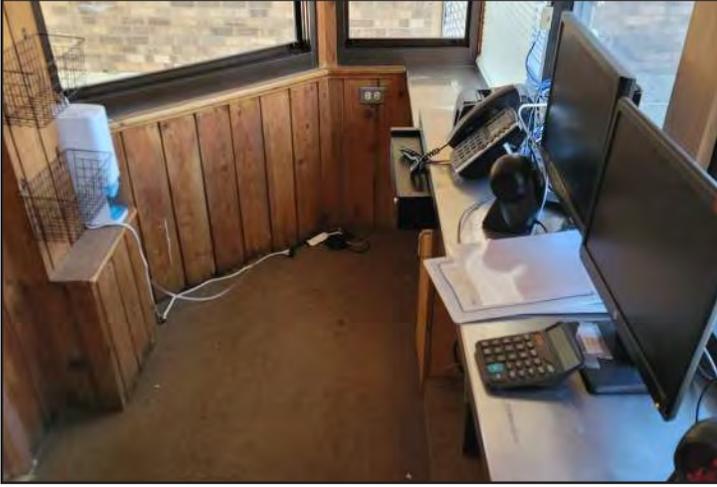
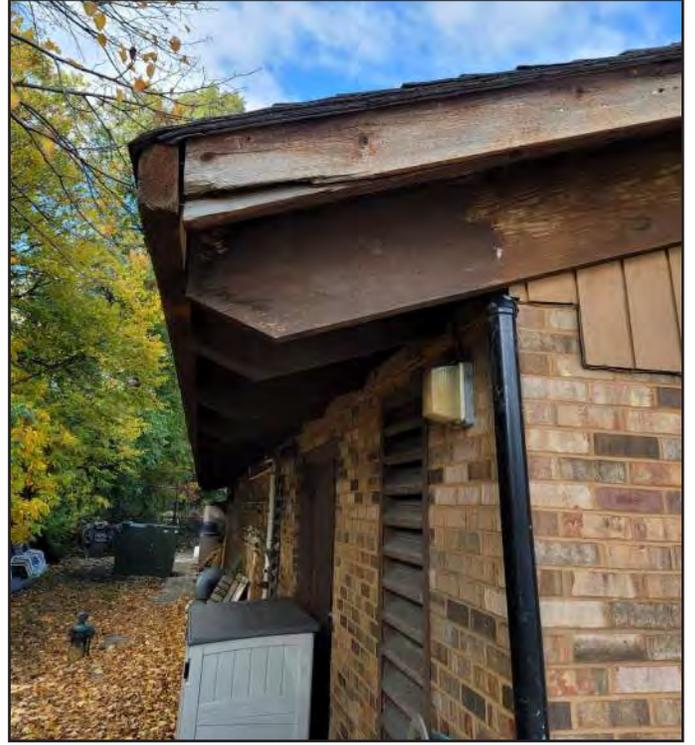
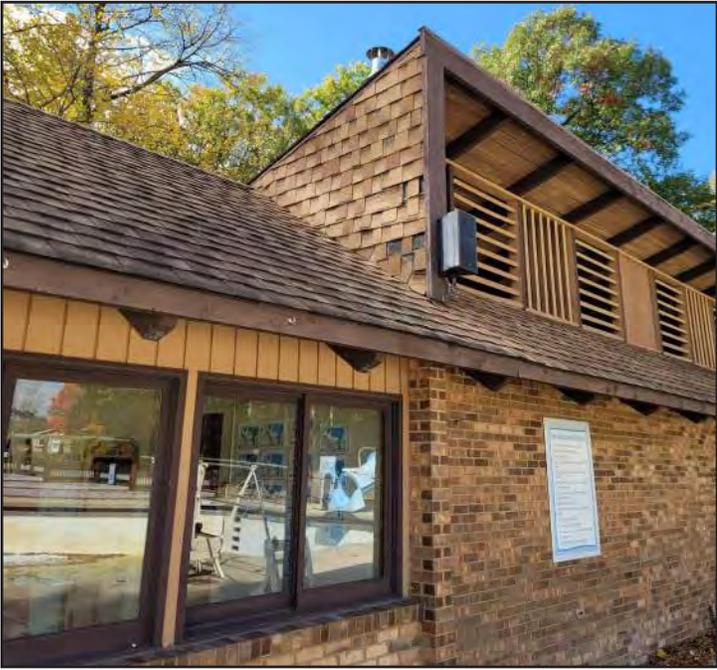
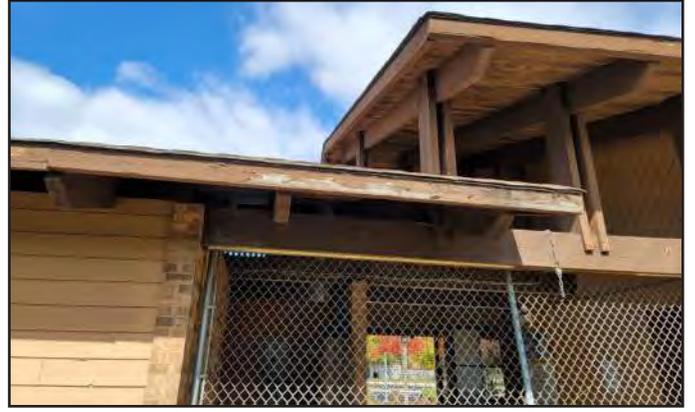
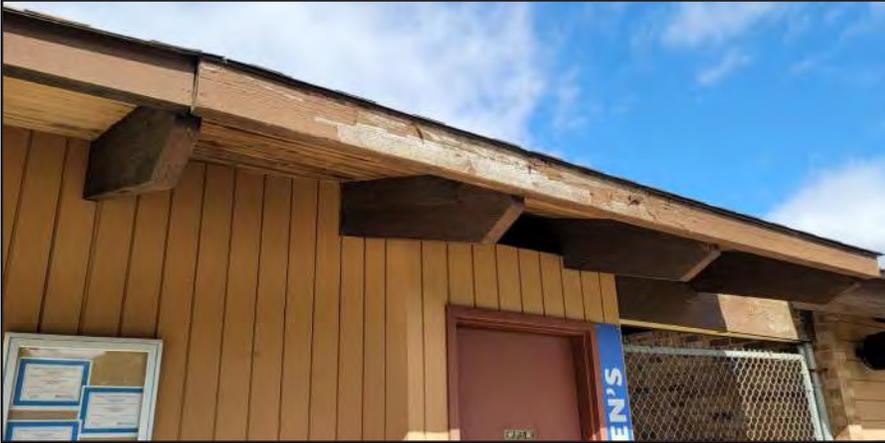
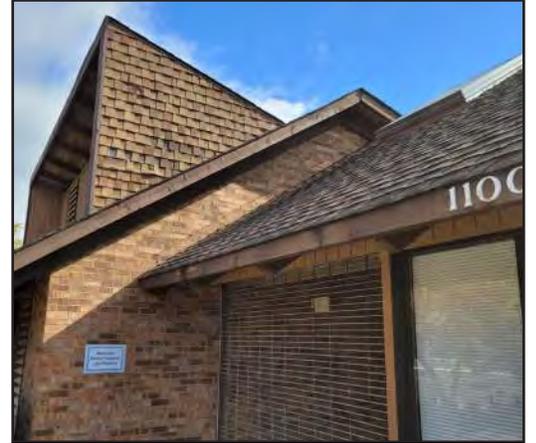
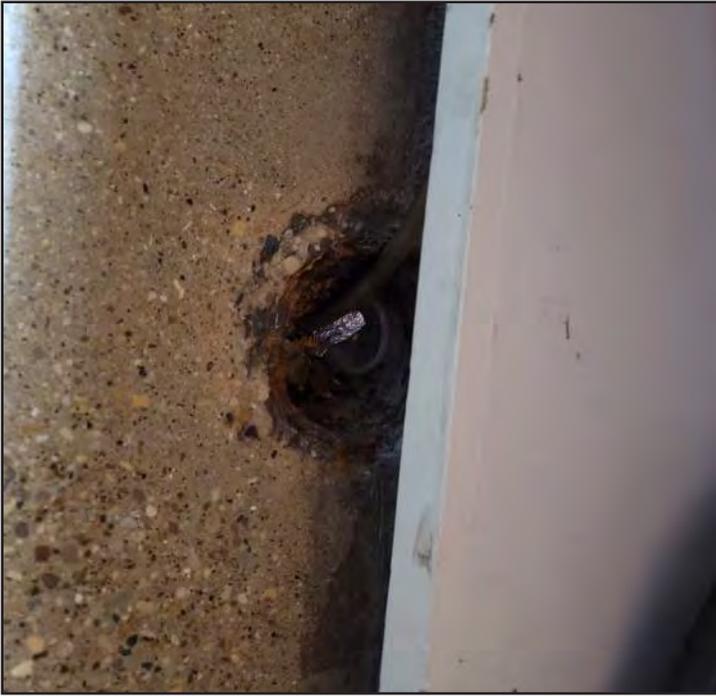
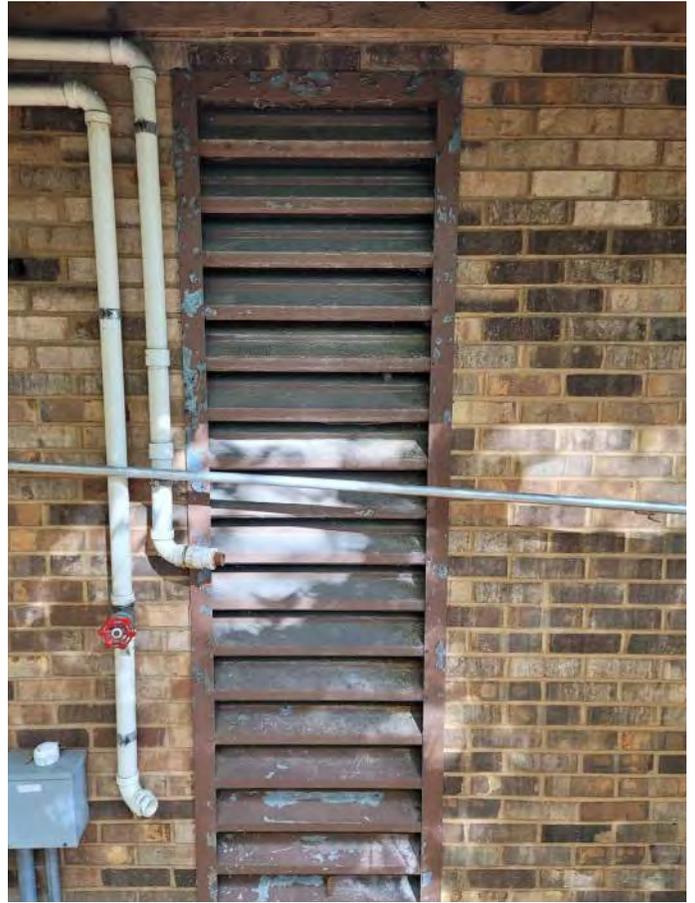
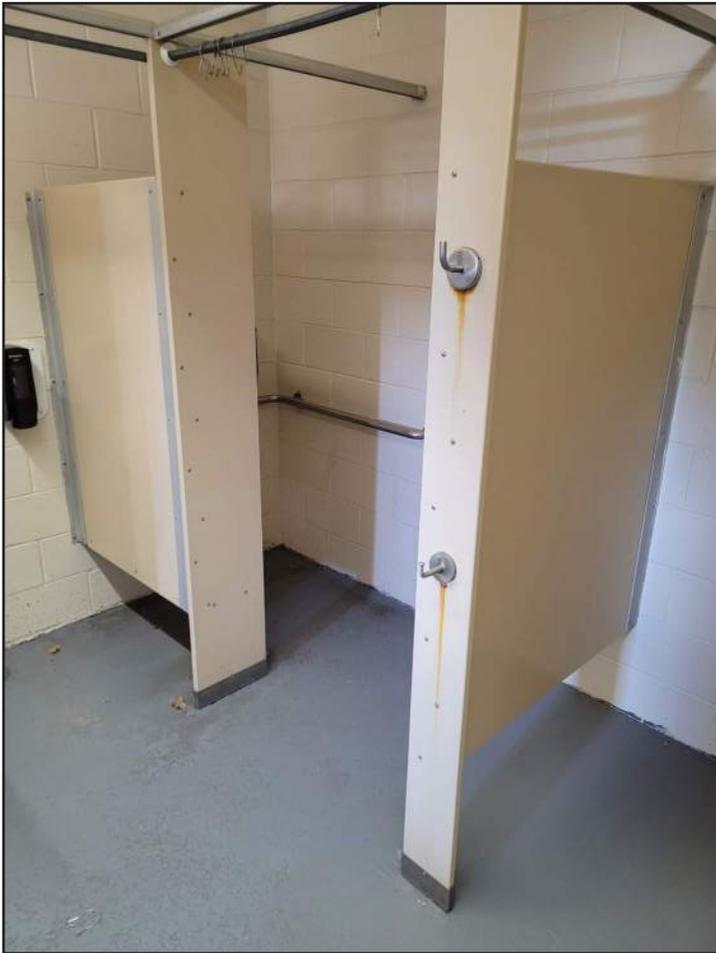
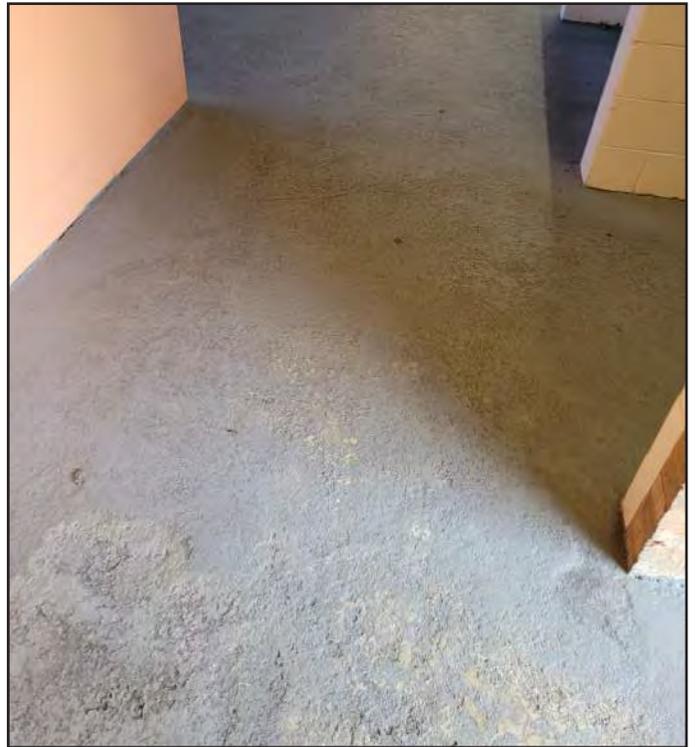
The Bathhouse at the Water Park and Splash Pad is in good condition overall. The toilet rooms need renovations to get them to full ADA compliance as do the showers and changing areas.

The epoxy flooring in the locker rooms is worn and in need of replacement. The staff spaces are undersized and would require small additions to be enlarged.

The wood siding on the exterior of the Bathhouse is worn and needs to be refinished or replaced.

The shingles on the sides of the dormers are

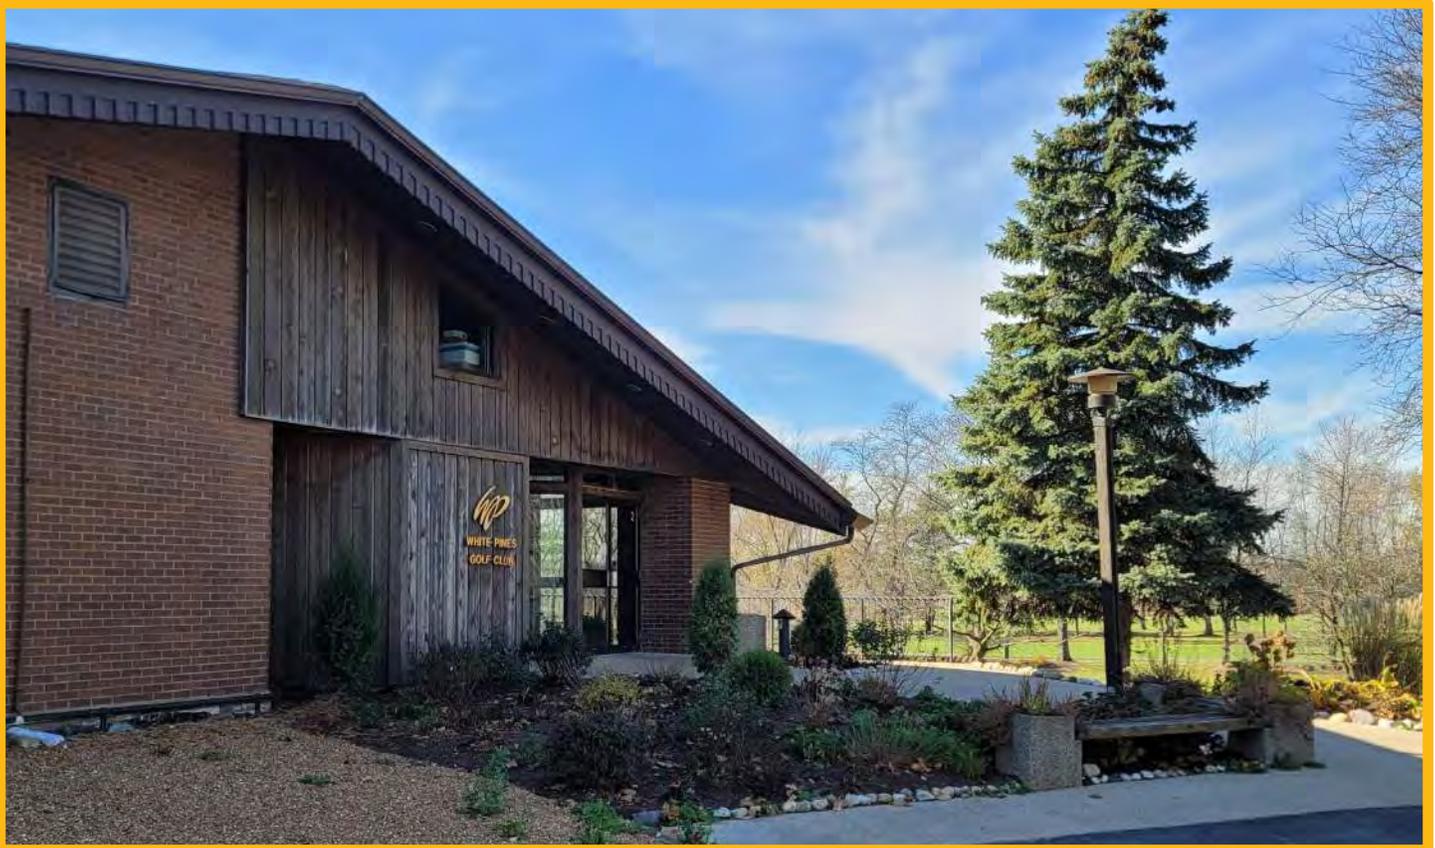
WHITE PINES GOLF CLUB BUILDINGS

The White Pines Golf Course has four buildings on the site. There is the club house, the old pro shop, the cart garage and the driving range building. The condition of the buildings varies but each is in need of major repairs and renovations in the near future.

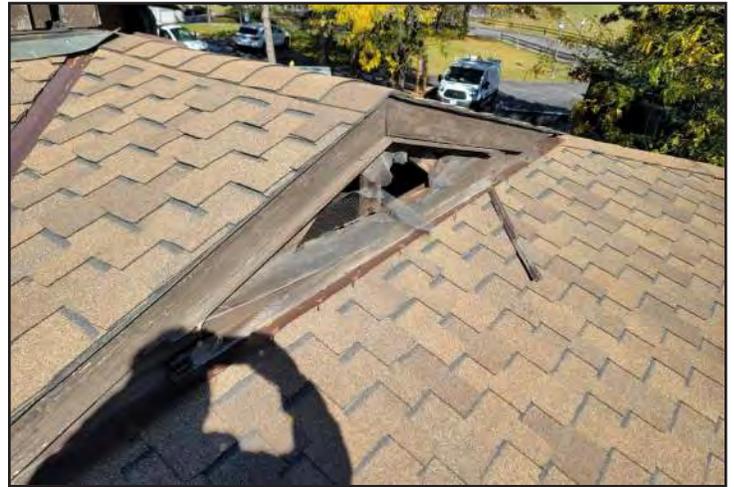
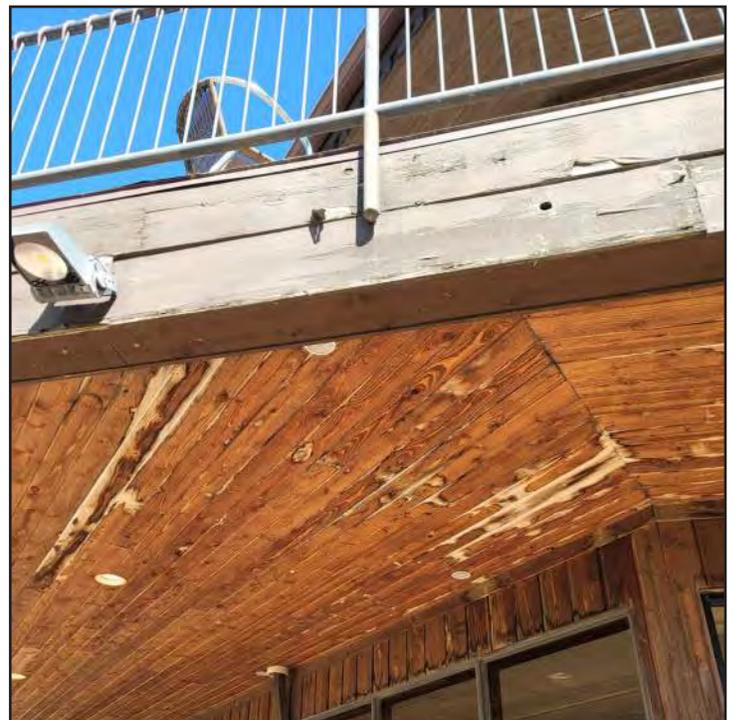
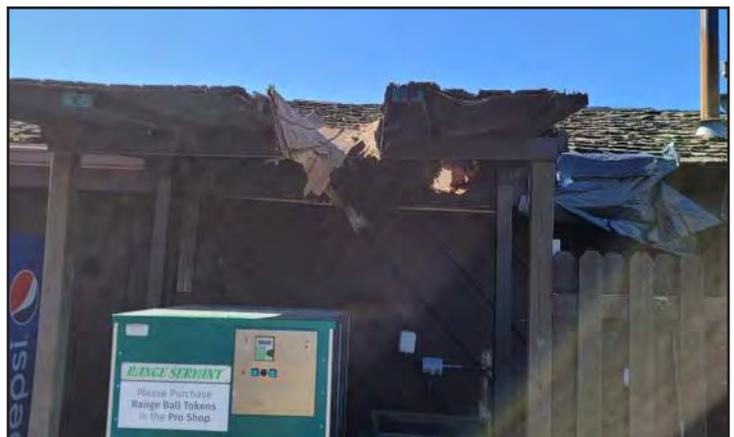
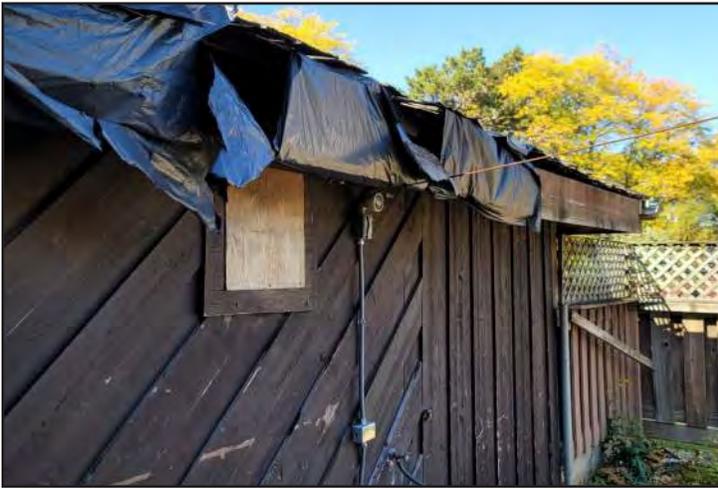
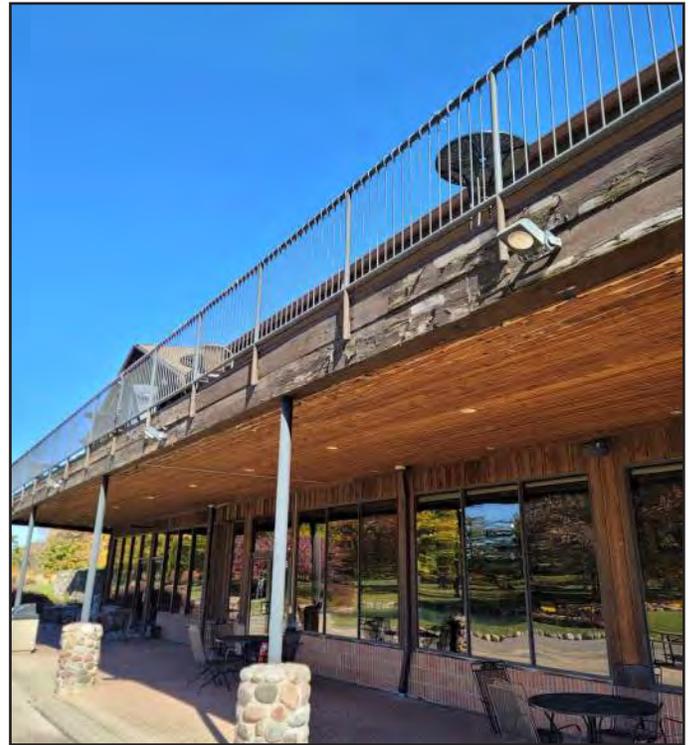
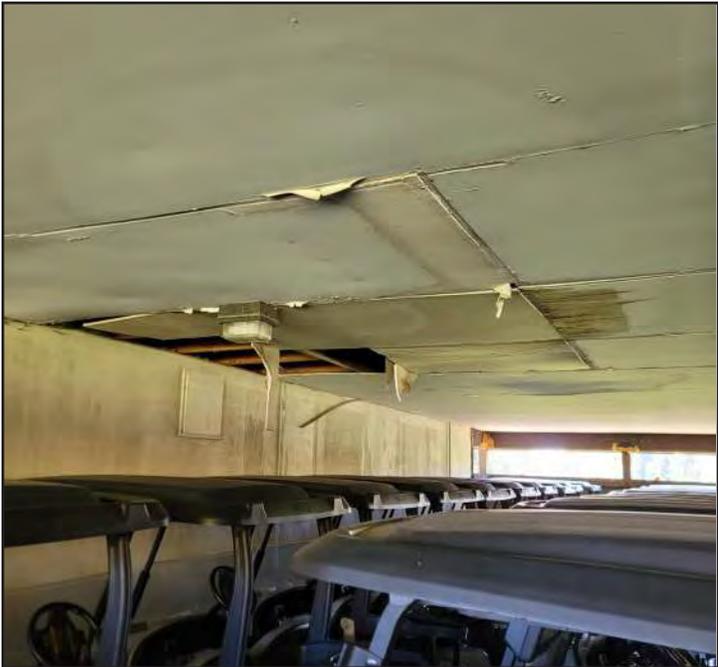
The exterior of the building is constructed of a combination of face brick and wood siding. Much of the wood siding is worn, rotted, or damaged and in need of repair or replacement. The roof has asphalt shingles with wood fascia and soffits. The wood fascia and soffits need repair or replacement. The shingles are in fair condition but will require replacement soon. There are several areas of wood siding above the roof that are heavily worn or damaged and urgently need repair or replacement. In addition, the mechanical units on the roof and on grade are nearing the end of their life expectancy and will need replacement in the near future.

The Golfcart Garage is in fair condition. The roof has several locations that have failed, and the roof needs to be replaced. The wood fascia and soffit are worn, damaged and rotting and require replacement. Several of the overhead doors are not functional and should be either replaced or the openings infilled with permanent wall construction. The wood siding is also in poor condition and should be replaced. On the interior, several areas of water damage to the ceilings in the garage were observed. At these locations, portions of the ceilings have collapsed inward.

Finally, the Driving Range Storage Building is in extremely poor condition. The wood shake roof has long since failed with several shingles missing completely. The wood siding around the building is in very poor condition. The awning over the golf ball dispenser has collapsed. TRIA was not able to assess the underlying structure of the building but given the condition of the outer shell we can only assume it is also in poor condition. We strongly recommend demolition of this building before any additional sections collapse. Alternate arrangements will need to be made for storage of the items housed within it.

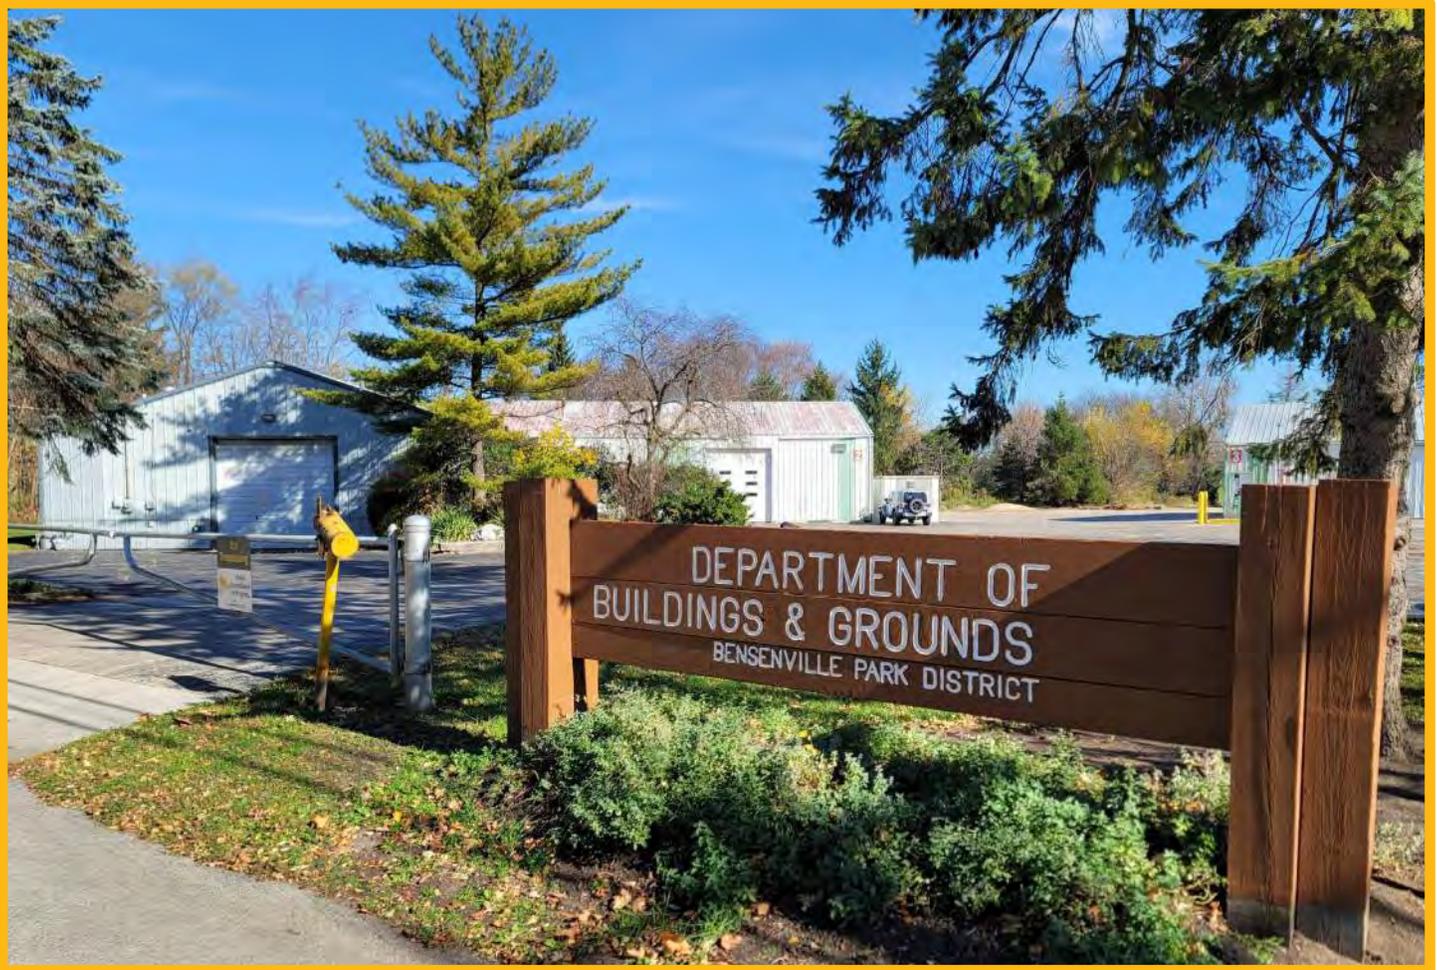
BUILDINGS AND GROUNDS FACILITY

Buildings one through four are constructed of a metal shell over wood or steel frame construction. These four buildings are in good condition for their use and construction type.

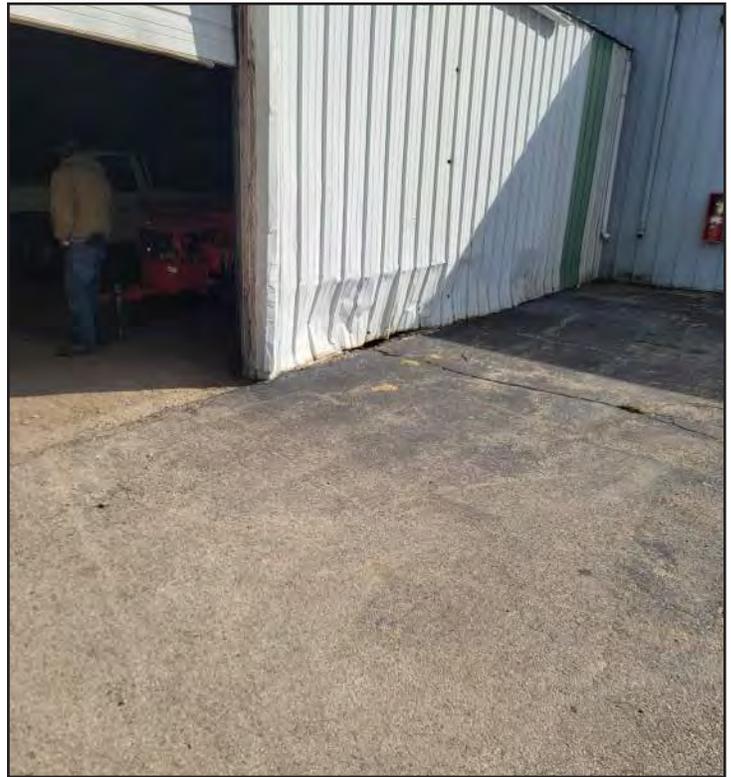
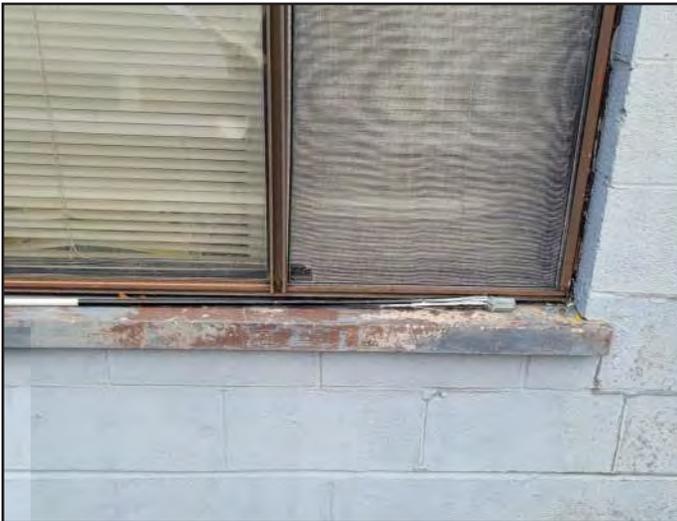
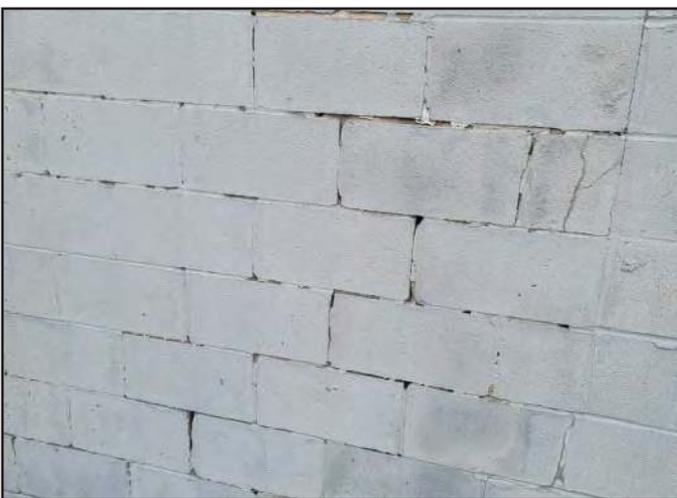
Wall panels on Building three have been significantly damaged by a vehicle near the fueling island. The fuel dispensers at the fueling island are showing signs of aging and wear. They do not appear to be in need of replacement at this time, but replacement should be planned for in the next several years.

Building five is constructed of a sloped roof bearing on single wythe concrete masonry unit walls. The masonry walls are in fair condition with numerous cracks visible. Inside the building, several areas of severe paint failure were observed.
